# Preliminary Investigation

**Morristown, NJ**

**Block 5906 Lots 6, 7, and 8**

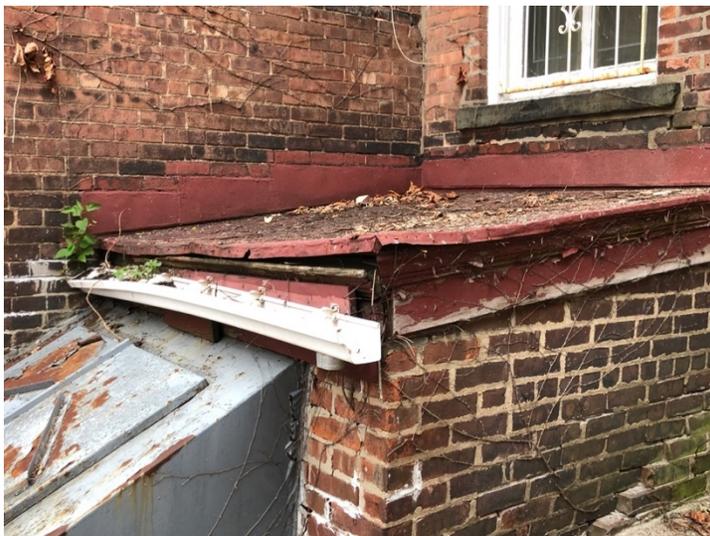
The building shows both cracks in the façade and chipped masonry. In some places, the brick has started to crumble and flake away, as shown below. On the back of the property, this condition is exacerbated by the excessive plant growth occurring on the exterior wall.

Figure 7: Cracks in exterior wall and bulging brick (see lower right).

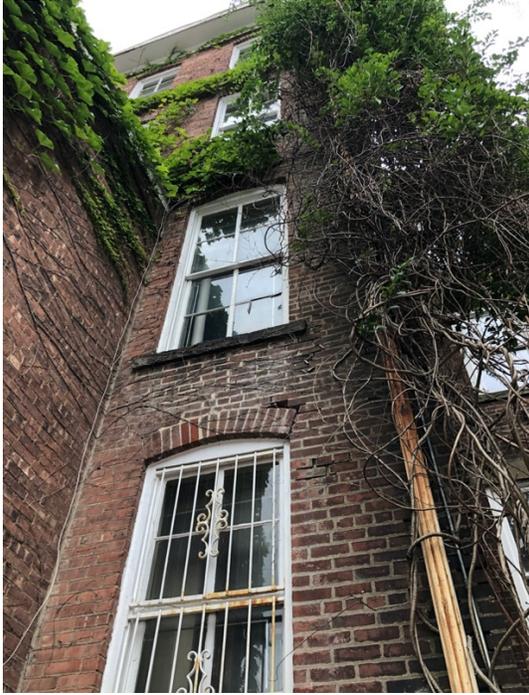
*Figure 8: Plant growth on exterior wall, exposed wires.*

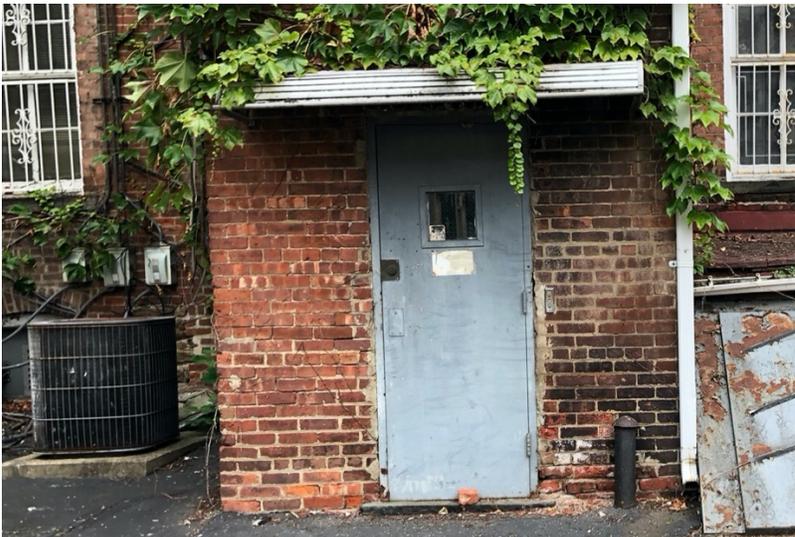
*Figure 9: Cracked masonry and fragmented mortar on exterior wall.*

An exterior inspection of the building revealed signs of spalling which can create safety hazards and compromise the structural integrity of the building. Spalling of the exterior wall can cause pieces of masonry to fall, which creates a safety hazard. Also, spalling in the foundation wall can over time negatively impact the structural integrity of the building as it no longer rests on a sound foundation. These safety hazards are conducive to unwholesome working conditions.

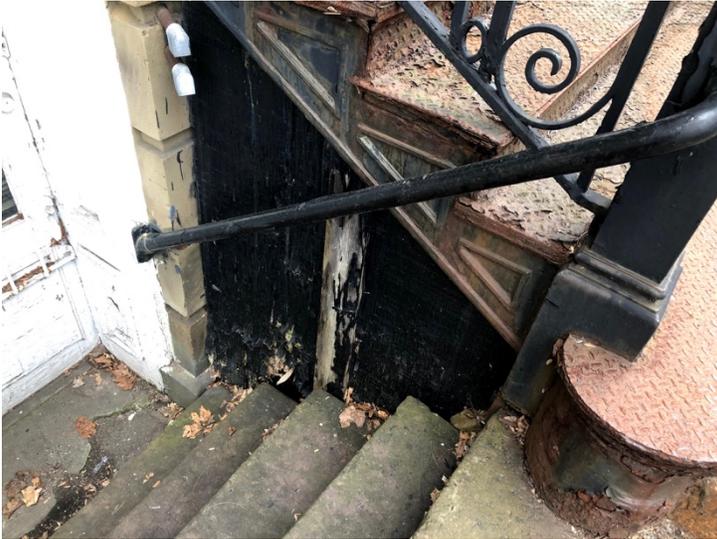
exhibit rotting wood (see Figure 10), rusting stairs and window frames (as shown in Figure 11), and deteriorating window enclosures. These conditions create unwholesome working conditions by creating dangerous access routes – especially the dilapidated building entrance on Washington Street, as shown in Figure 12 – that present safety hazards for individuals entering and exiting the building.

*Figure 10: Rotten wood near Washington Street entrance.*

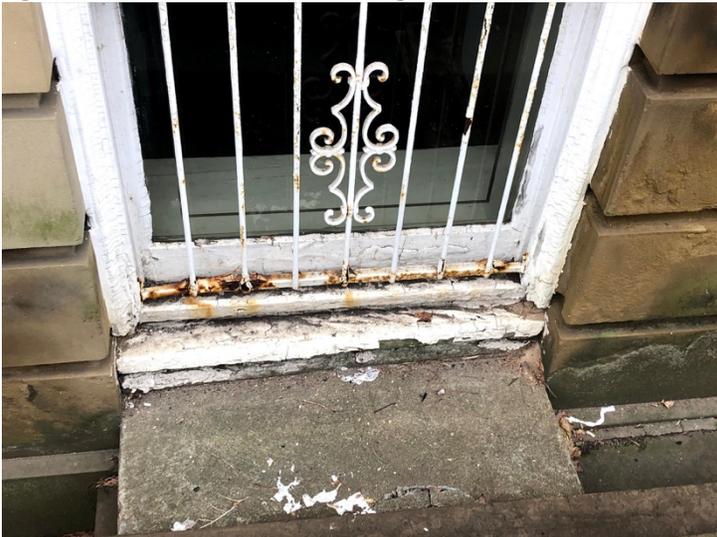
*Figure 11: Rusted window enclosure.*

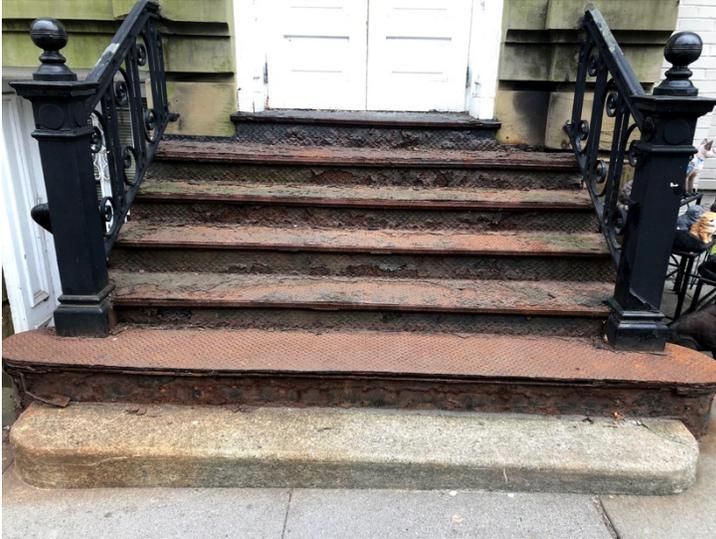
Figure 12: Dilapidated building entrance.

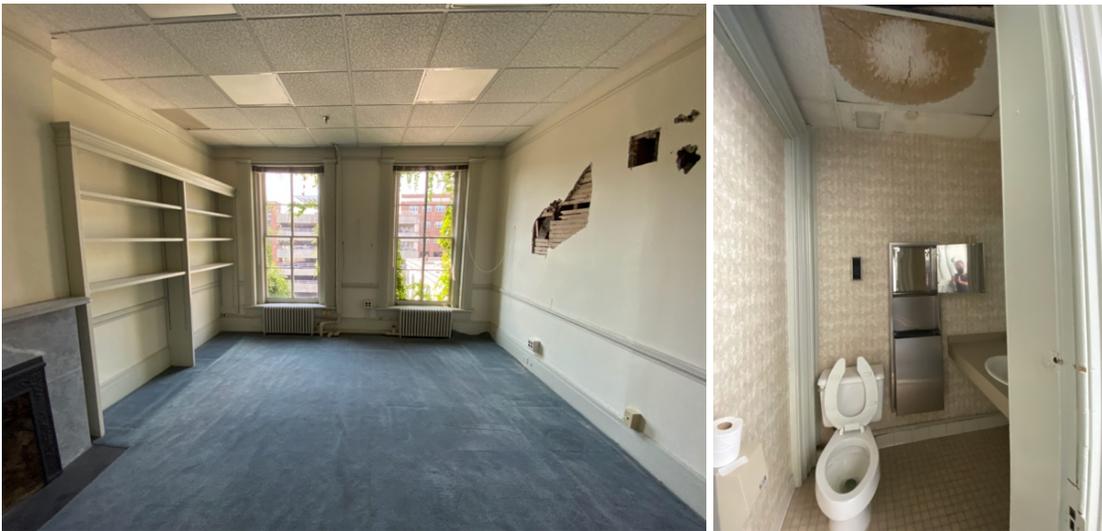
Figure 13, 14: Holes in walls; evidence of water intrusion in the ceiling

These observed interior conditions are conducive to unwholesome working conditions. Holes in walls create an unsightly working condition and may expose workers to wiring, insulation or other hazardous materials enclosed within walls. Many of the holes were the result of water damage and/or emergent pipe / leak repairs. Water intrusion of this nature promotes mold growth, which is supported by presence of “mildew” odor observed during the site inspection. Water damage can compromise the integrity of building materials and increase the risk of injury due to falling debris.

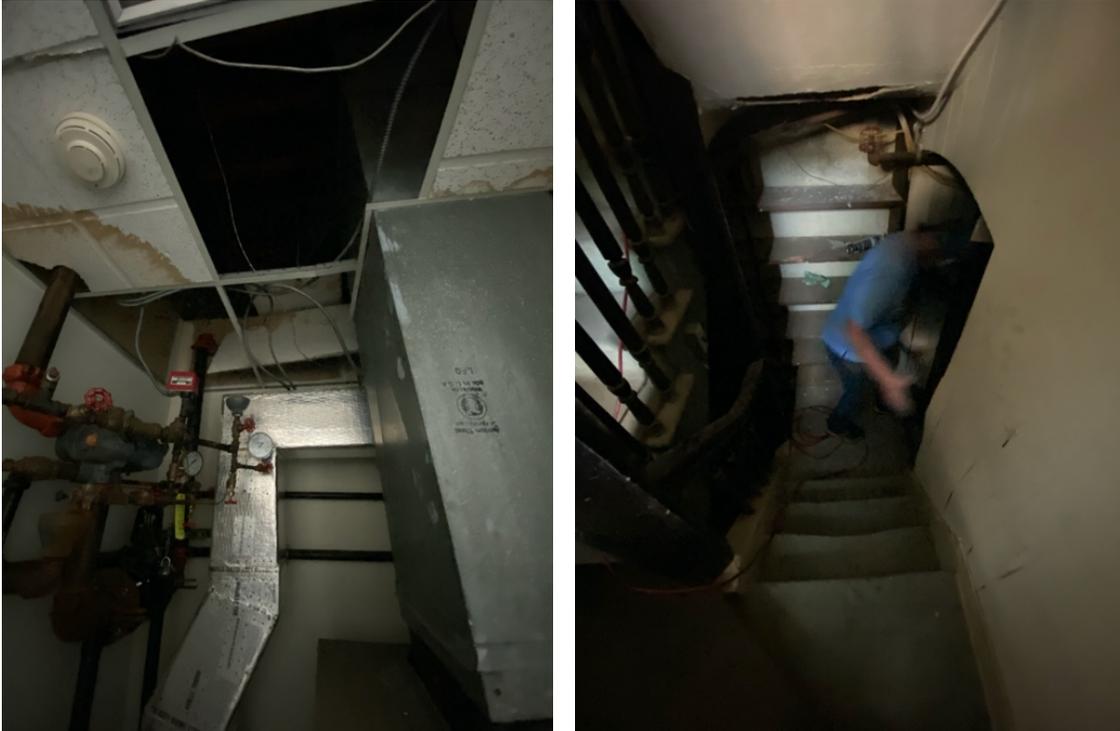
Figure 15, 16: Missing ceiling panels and exposed wires; compromised stair structure.

Critical building elements in disrepair, like the stairs shown in Figure 16 create dangerous emergency routes for workers. Exposed wires, as observed, create safety hazards for workers that may come in contact with live electrical equipment. Scattered debris, as observed in the basement, creates both tripping hazards and substrate for pathogen growth. These interior building conditions, particularly when considered in their totality, reflect a substandard, unsafe, and dilapidated condition that is conducive to unwholesome working conditions.

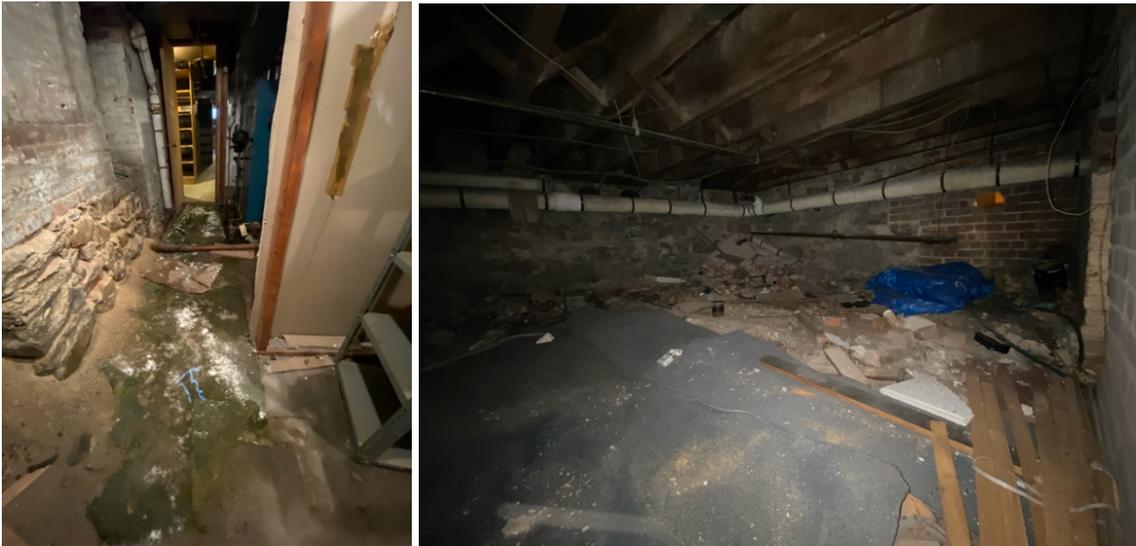
Figure 17, 18: Evidence of water intrusion in the basement; scattered debris in the basement.

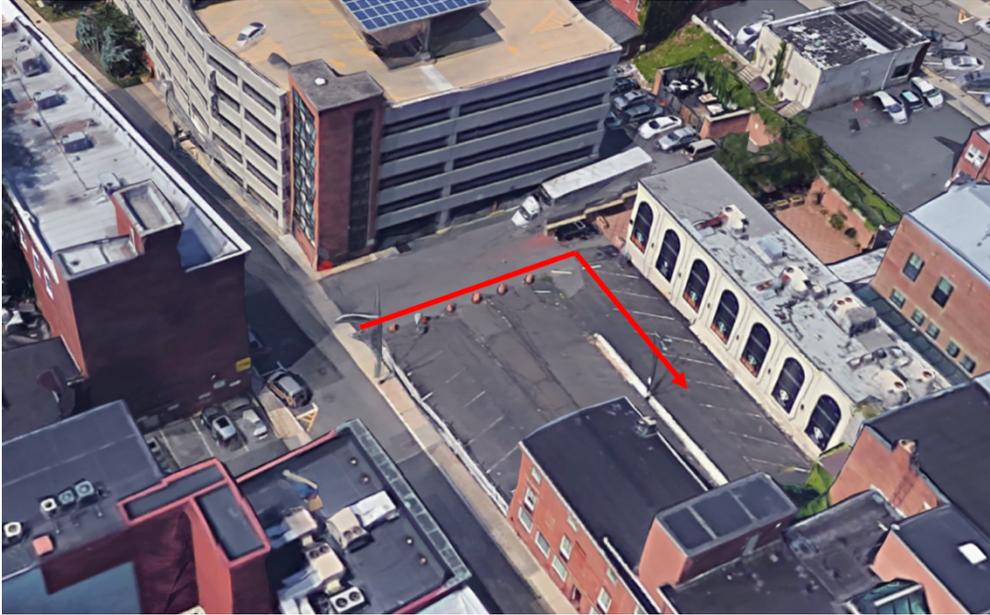
The parking area in the rear of the lot exhibits faulty arrangement in a manner that is detrimental to the safety of the community. Access to the rear parking area of Lot 6 is provided via a narrow driveway. There is a convergence of access patterns on this driveway, including vehicles accessing loading on Schuyler Place, the public parking garage, and the Study Area properties. This creates an unsafe situation and conflict points between cars accessing the site and those accessing these other uses. Vehicles forced to back out of the property due to the one-way circulation pattern could easily come into conflict with vehicles utilizing the garage or loading along Schuyler Place. The dangerous nature of these movements is compounded by limited sight lines. The relationship between the properties and the various access points is reflected in the figure below.

*Figure 22: Access to parking and loading for Lot 6 via narrow rear drive with conflicting users*

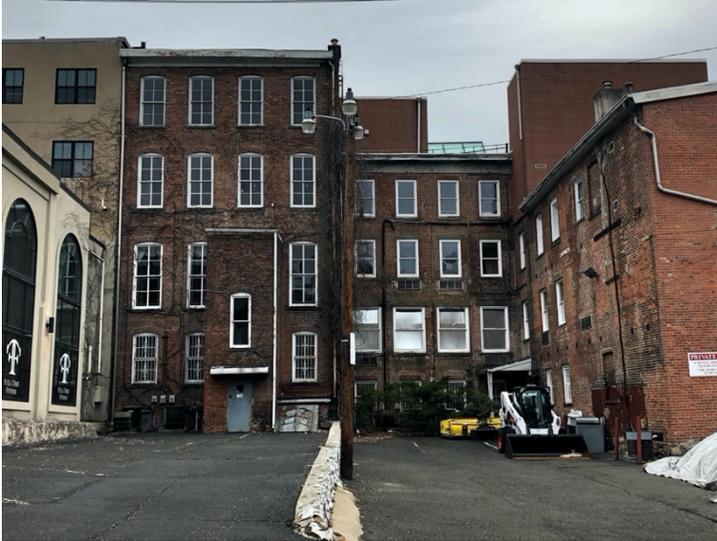
As reflected in the figure below, the property also possesses dilapidated improvements. Pavement in the parking and circulation area and the low retaining wall show signs of settling and potential water intrusion. While it appears that some effort was made to repair the retaining wall, the deteriorated condition persists, and no associated construction permit was identified. The conditions on-site, including the absence of screening or landscaping, have a deleterious impact on the surrounding properties by creating an unsightly appearance. These conditions could reasonably be expected to discourage adjacent property owners from undertaking investment and are therefore detrimental to the welfare of the community.

*Figure 23: Dilapidated parking area and retaining wall; absence of clear circulation patterns, absence of screening and landscaping.*

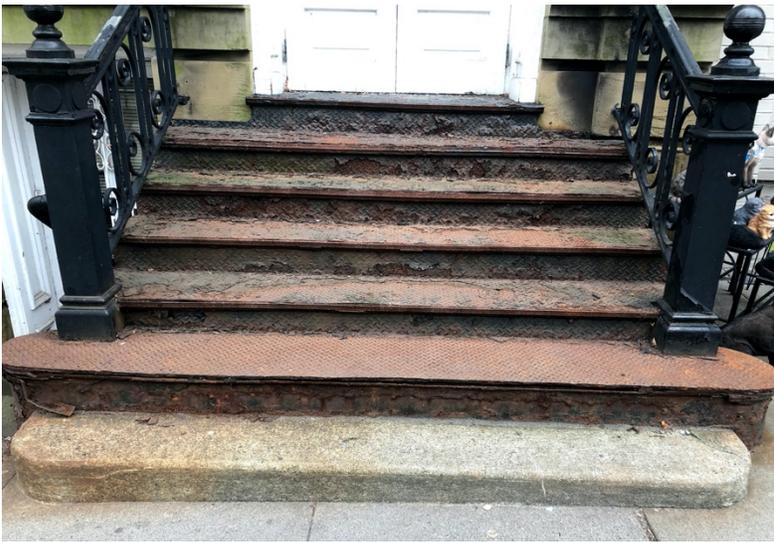
(Americans with Disabilities Act) regulations. The existing entrance fails to comply with these regulations. As a result, it does not allow full and equal access to people with disabilities and is not conducive for ground floor uses permitted under the zoning.

*Figure 24: Obsolescent access on Washington Street.*

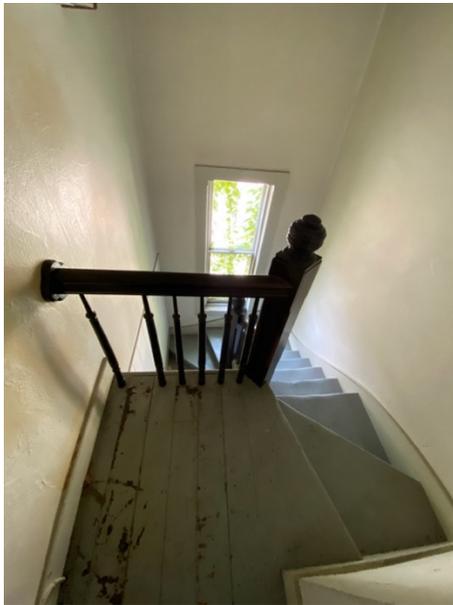
Internal conditions are also reflective of inadequate ADA accessibility and support the conclusion that the building exhibits characteristics of obsolescence. As reflected in the figure below, stairways within the structure (including what appear to be all means emergency egress) are narrow and difficult to climb. Furthermore, the retrofitting of the three separate properties to accommodate a single user has resulted in a configuration that requires the use of a network of small, internal staircases or, in some cases ramped floors, to accommodate varying floor heights. This condition, which will be evidenced in photos for subsequent properties, inhibits circulation for users with mobility impairments. Limited accessibility is reflective of obsolescence and, is detrimental to the morals and welfare of the community because it limits the range of individuals that can be accommodated within the building and inhibits potential reuse of the structure.

*Figure 25: Steep and narrow staircase*

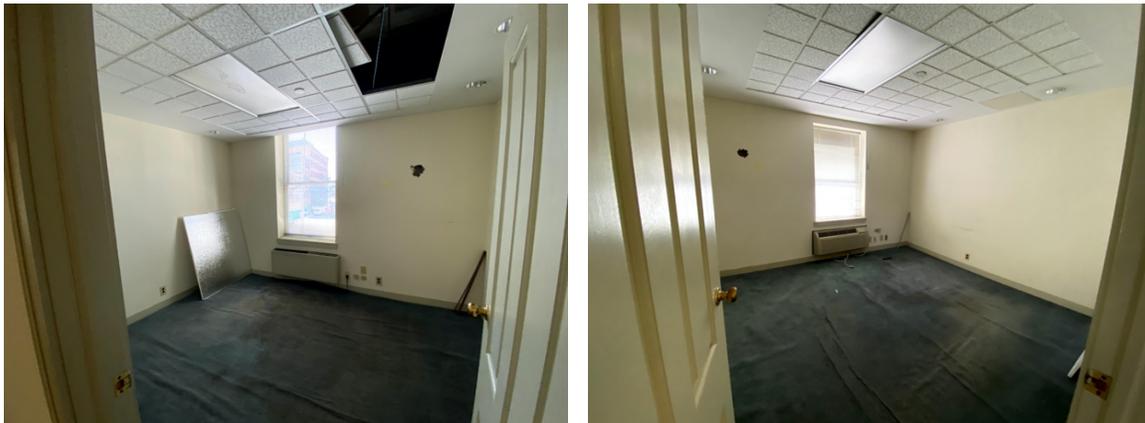
Figure 26, 27: Holes in ceiling; separation of ceiling tile.

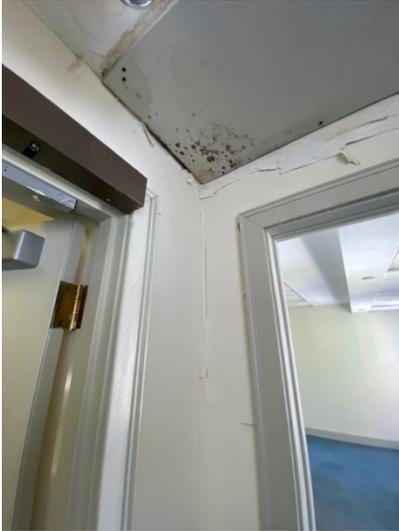
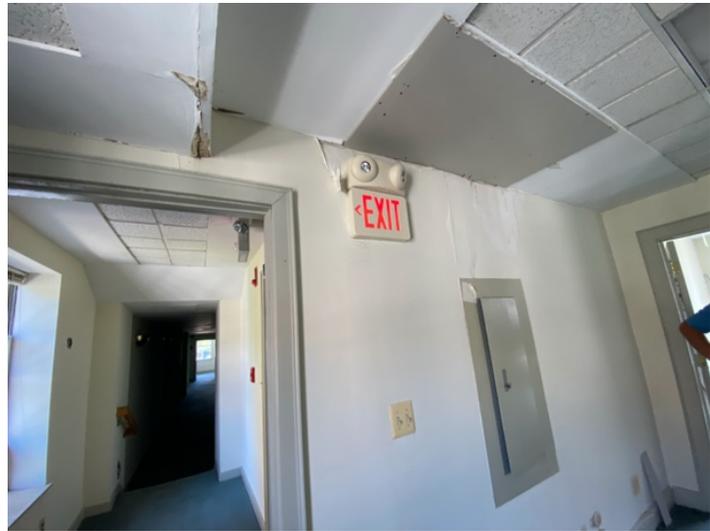
Figure 28, 29: Evidence of water damage in ceiling and walls; separating joints; cracked ceiling elements

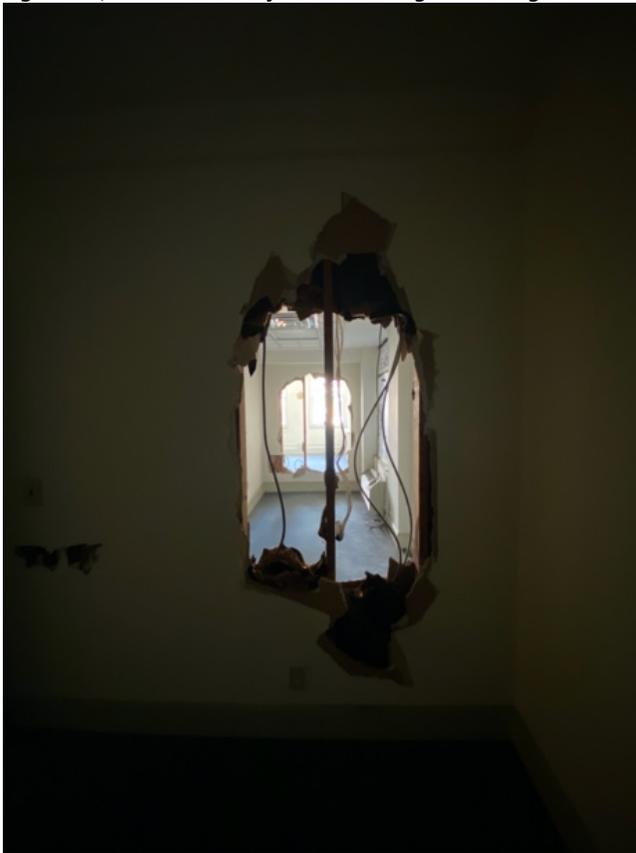
Figure 30: Holes in walls, exposed wiring

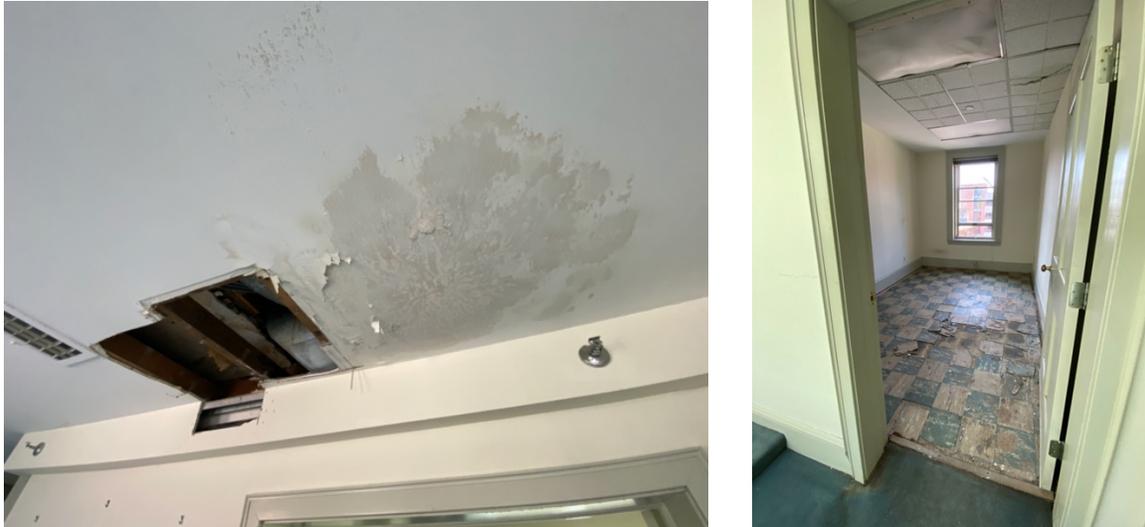
Figure 31, 32: Hole in ceiling; water intrusion in ceiling; dilapidated floor tiles

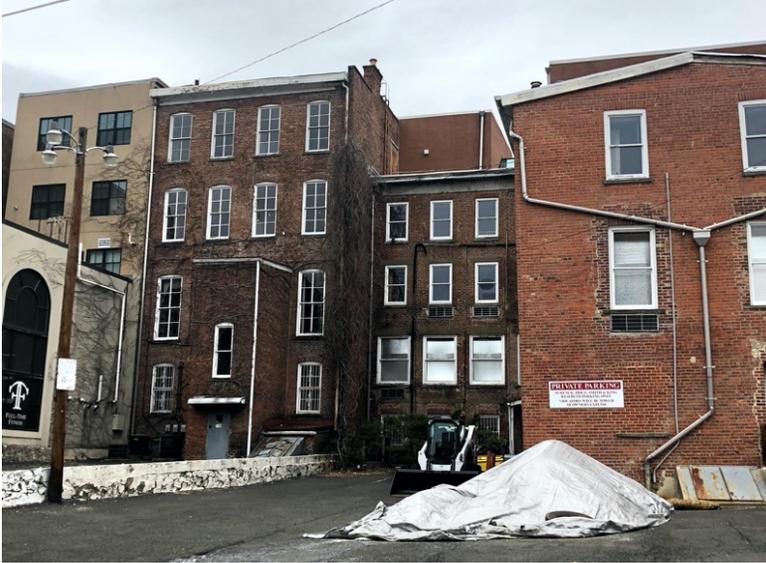
absence of screening or landscaping have a deleterious impact on the surrounding properties by creating an unsightly appearance. These conditions could reasonably be expected to discourage adjacent property owners from undertaking investment, thereby having a detrimental impact on the community's welfare.

*Figure 39: Dilapidated improvements; absence of marking.*

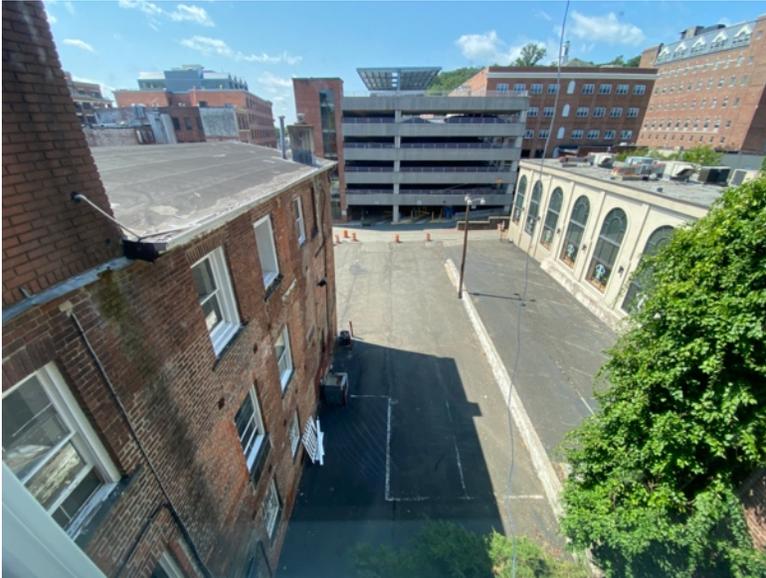
*Figure 40: Unstriped parking area shared with adjacent lots*

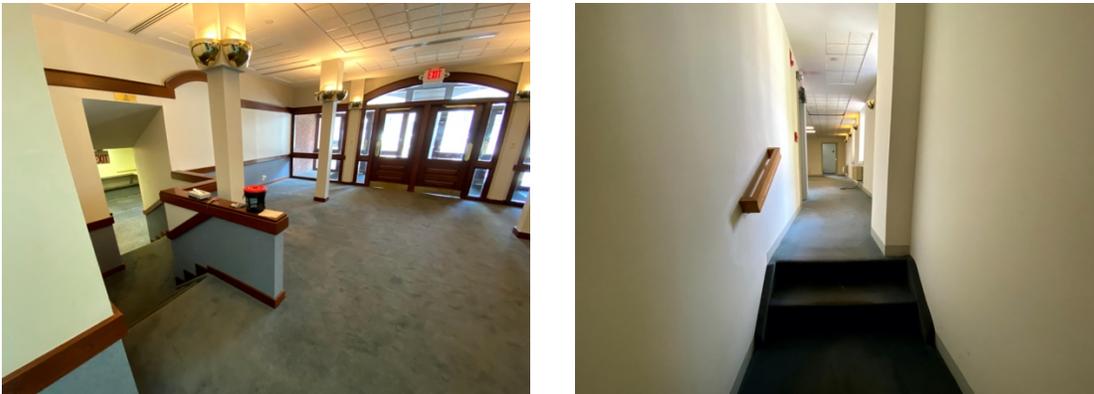
The interior inspection also revealed characteristics of obsolescence related to property accessibility. Because the three properties have been retrofitted to accommodate a single user, the resulting configuration is a circulation network that requires the usage of numerous small internal staircases or, in some cases ramped floors, to accommodate varying floor heights. This condition, as reflected in the figures below, inhibits circulation for users with mobility impairments. Limited accessibility is reflective of obsolescence and, as noted previously, is detrimental to the morals and welfare of the community because it limits the range of individuals that can be accommodated within the building and inhibits potential reuses of the structure.

*Figure 41, 42: Small staircases required for internal circulation limit accessibility of property*

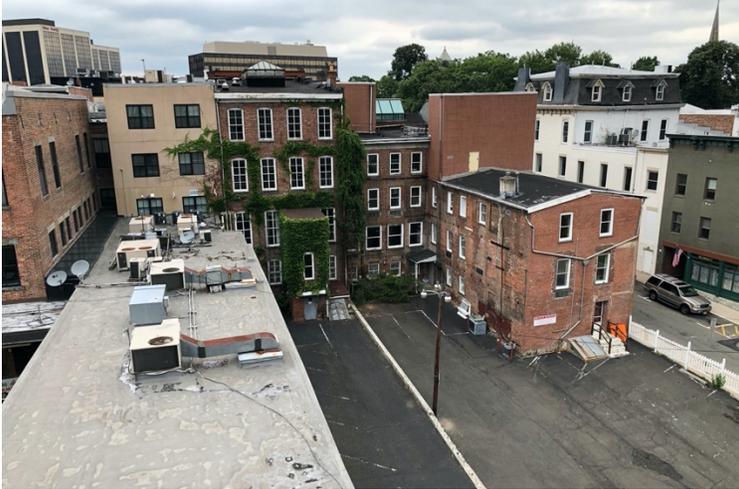
Furthermore, the property exhibits excessive land coverage. Based on an aerial assessment, site visits, and property documentation, the maximum improved coverage is roughly 95% as natural or landscaped areas are almost completely absent on-site. As noted, before, excessive land coverage negatively impacts the health, safety, and welfare of a community by exacerbating flooding, stormwater runoff, and non-point source pollution. Excessive land coverage detracts from the welfare of the community by creating a less hospitable landscape that discourages pedestrian activity. Pedestrian activity is an essential component of a modern downtown and conducive to creating a thriving business environment.

Figure 43: Excessive land coverage.

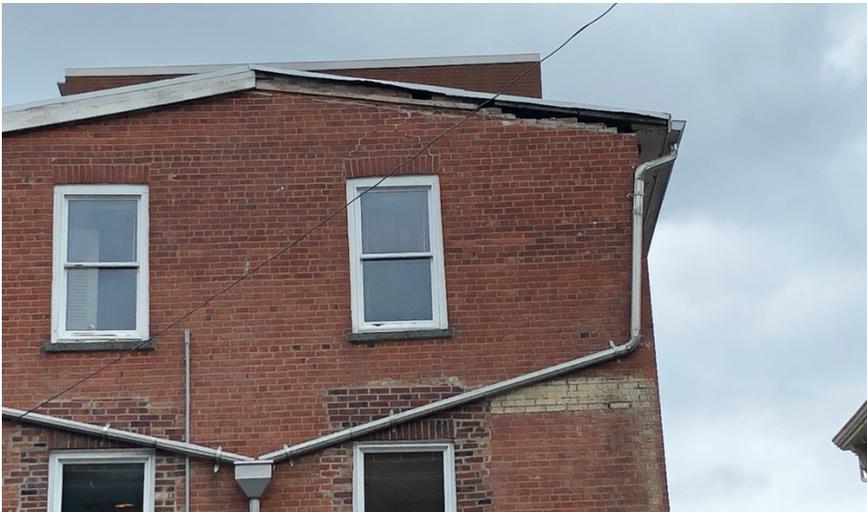
The building façade in the rear of the lot has damaged and missing roof-top and fascia elements, as shown below.

Figure 44: Missing fascia element.

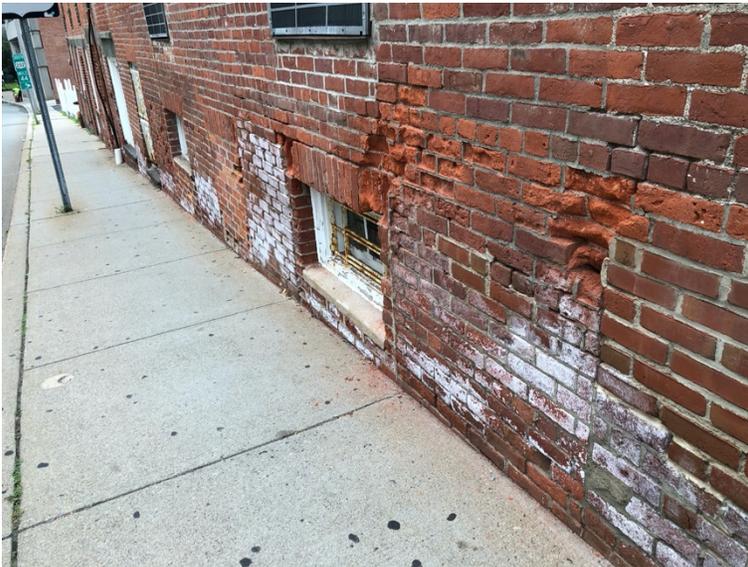
Both buildings also show cracks in the façade as well as chipped masonry. In some places, the brick has started to crumble, and flake away, as shown below.

*Figure 45: Cracks and chipped masonry visible on exterior wall.*

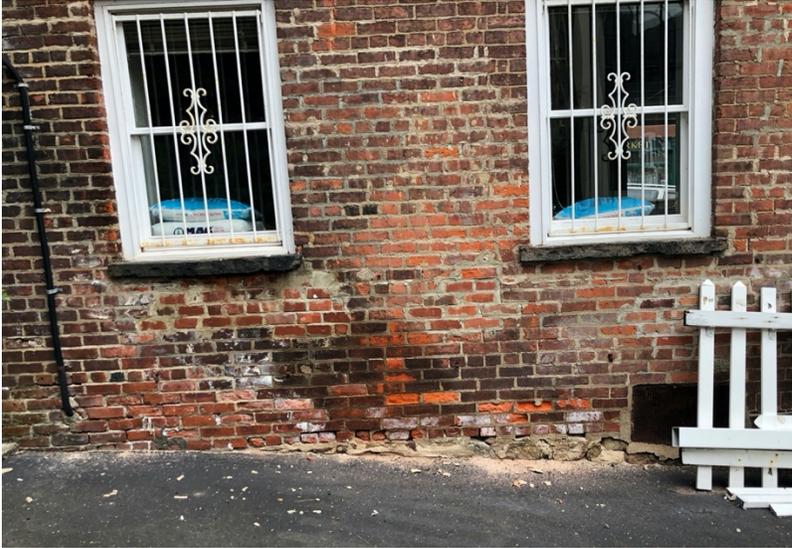
Figure 46: Cracked masonry and fragmented mortar on foundational wall.

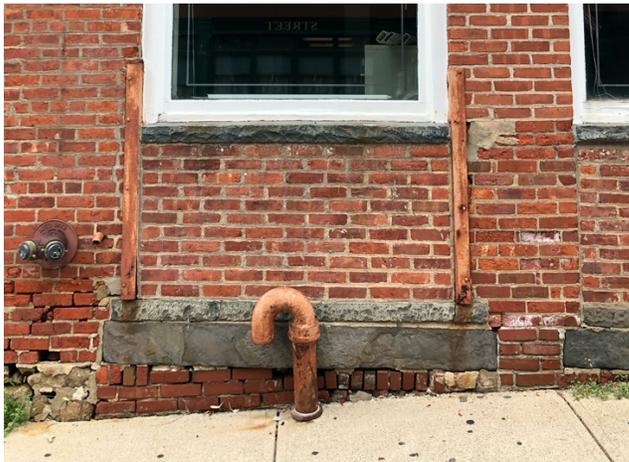
Figure 47: Visible spalling in foundation wall.

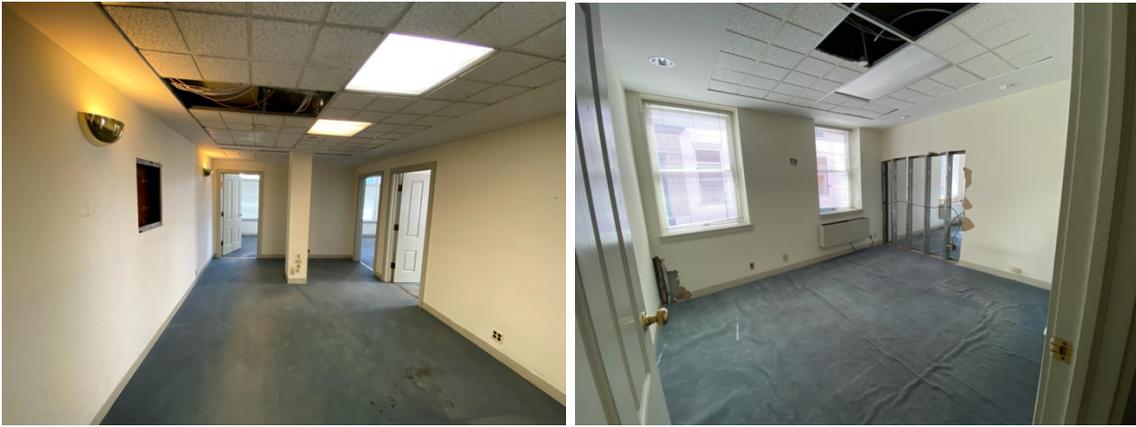
Figure 48, 49: Missing ceiling panels and exposed wiring

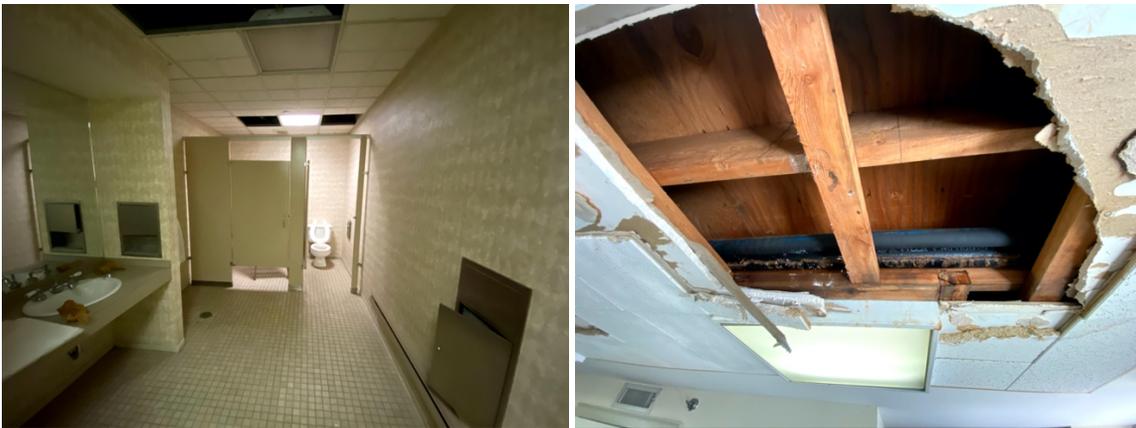
Figure 50, 51: Missing ceiling panels and dilapidated ceiling exposing building infrastructure

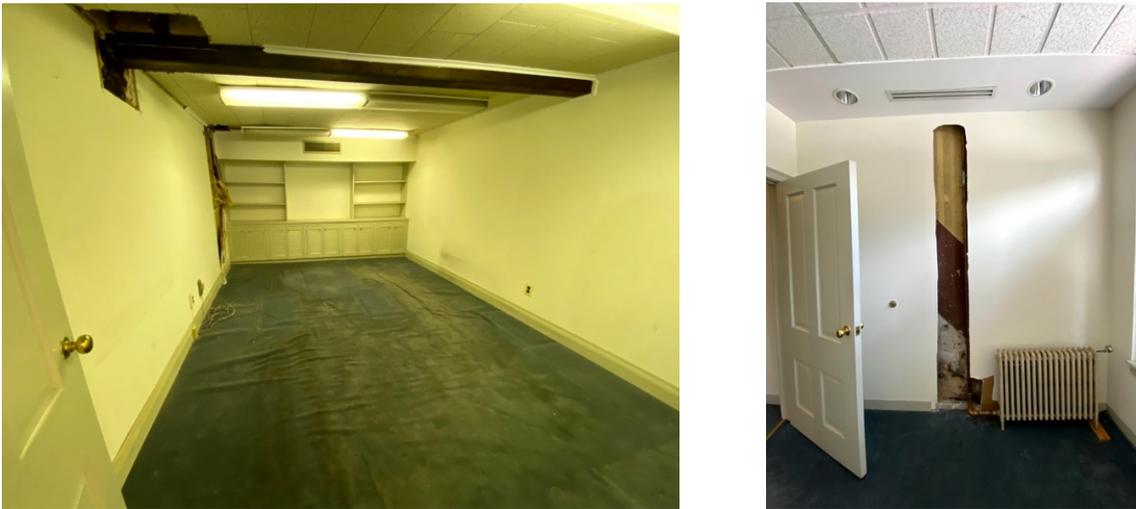
Figure 52, 53: Dilapidated ceiling, hole in wall

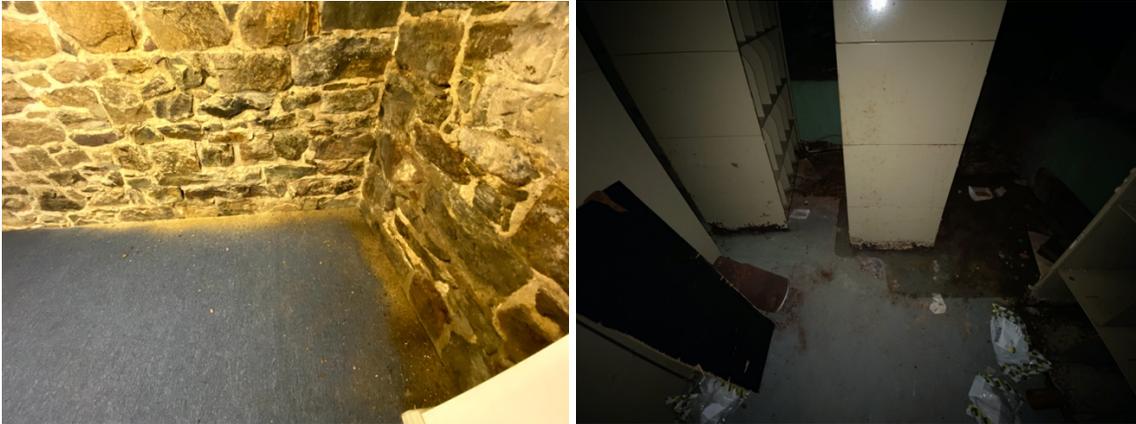
Figure 54, 55: Evidence of water damage along edges of floors; haphazardly stored material in basement

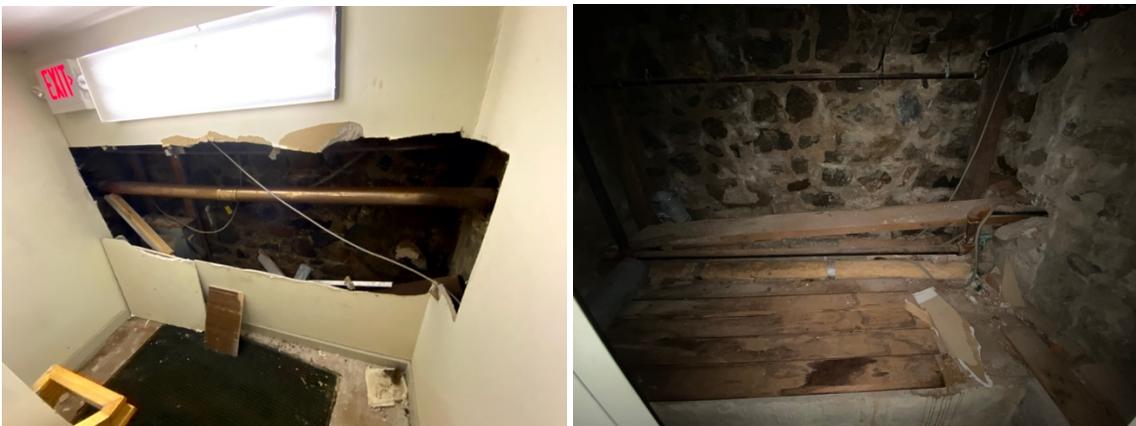
Figure 56, 57: Large hole in wall exposing building infrastructure; debris and evidence of water damage in basement

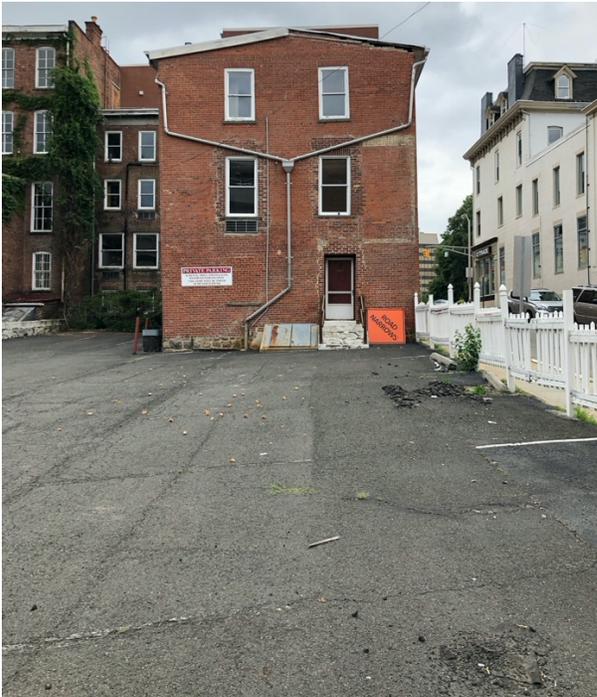
As reflected in the figure below, the property also possesses dilapidated improvements. Pavement in the parking and circulation area signs of settling and potential water intrusion. The conditions on-site, including the absence of landscaping, have a deleterious impact on the surrounding properties by creating an unsightly appearance. These conditions could reasonably be expected to discourage adjacent property owners from undertaking investment.

*Figure 63: Dilapidated improvements; absence of clear marking and landscaping.*

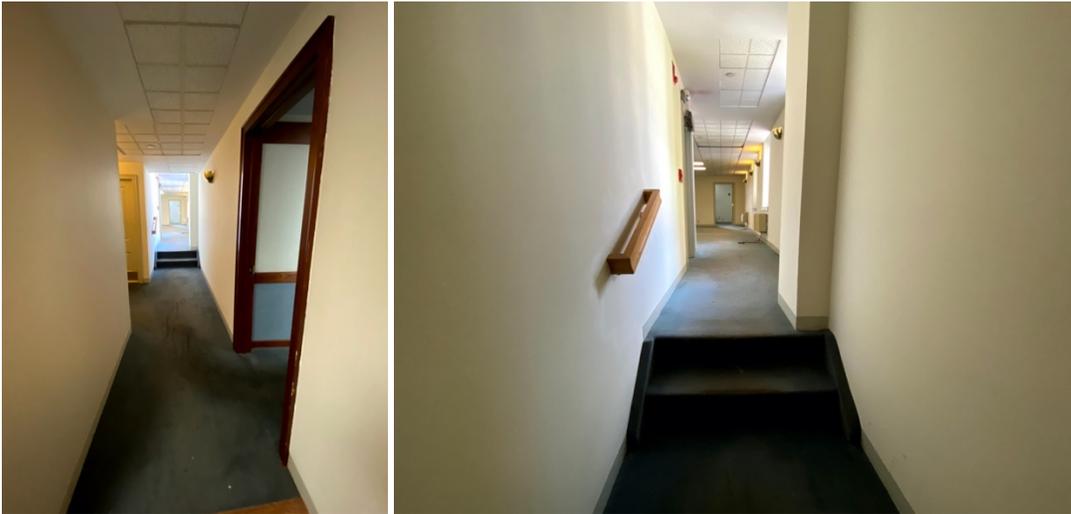
The interior inspection also revealed characteristics of obsolescence related to property accessibility. As noted, because the three properties have been retrofitted to accommodate a single user, the resulting configuration is a circulation network that requires the use of a network of small, internal staircases or, in some cases, ramped floors, to accommodate varying floor heights. This condition, as reflected in the figures below and elsewhere throughout this report, inhibits circulation for users with mobility impairments. Limited accessibility is reflective of obsolescence and, as noted previously, is detrimental to the morals and welfare of the community by limiting the range of individuals that can be accommodated within the building and inhibiting potential reuses of the structure.

*Figure 64, 65: Internal staircases limiting accessibility*
