Design Guidelines

A Handbook for the Preservation and Improvement of Morristown's Historic Properties

May 2006

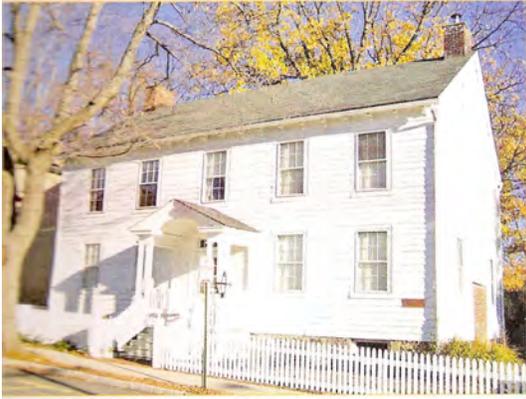
Georgian buildings are more formally arranged than their Colonial predecessors. Symmetry and classical details such as urns on pedestals, floral motifs and fluted columns are employed on the exterior, especially on the primary facade. Typically in high-style Georgian buildings, the exterior has a coursed ashlar finish (or a simulated ashlar finish of scored stucco) with heavy quoins terminating the corners. But since Morristown was still largely rural, it was not influenced as much by high-style Georgian architecture, and its Georgian buildings continued with the traditional clapboard siding on the exterior. A heavy modillioned cornice is generally used at the eaves. The primary facade often contains a pedimented projecting pavilion with large pilasters or columns and a Palladian or Venetian window. Windows are more commonly of the single or double-hung type with 6 to 18 lights per sash rather than the diamond-pane casement type used when glass was rarer and more expensive. Above the windows there is often found a flat arch with pronounced keystone. The doors are generally paneled. The front door may have a transom light, side lights, or both, flanked by pilasters and/or columns. Often pedimented dormers are included to bring light to the attic spaces. The typical house plans also became more elaborate, with separation of family areas, dining rooms, bedrooms, and cooking areas.

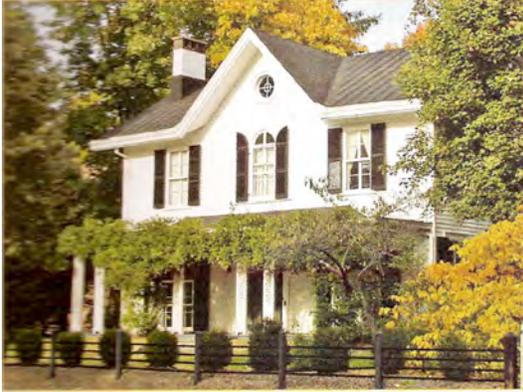
Widely used for many different building types, this style is characterized by steeply pitched roofs, wall dormers, polygonal chimney pots, hood molds over the windows, and curvilinear "gingerbread" trim along the eaves and gable edges. The standard for windows in this style varies, but the pointed arch is often characteristic.

Vernacular versions of this style were commonly used for residences such as the Admiral Rodgers house at 40 Macculloch Avenue. The Church of the Redeemer on South Street, built in 1917, is a Gothic Revival style replacement of an original Gothic Revival building.

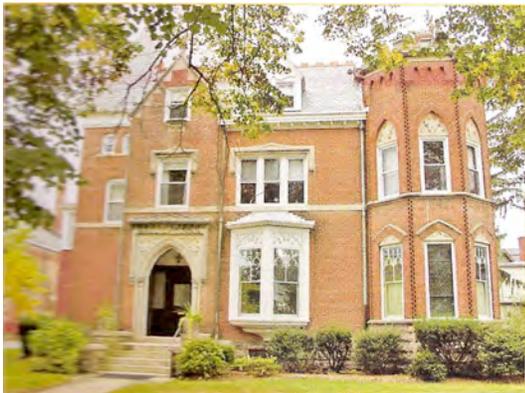
Richardson Romanesque

The Richardsonian Romanesque style got its name from the Boston architect Henry Hobson Richardson. While this style is generally similar to the Victorian Gothic, architect Richardson set it apart by the use of Spanish and French influences. This style is distinguished by the use of the semi-circular arch, broad roof planes and a rusticated exterior finish. The overall effect depends on mass, volume and scale rather than on ornamentation and decorative detailing. In masonry buildings, the semicircular arches are often supported by short polished stone columns.

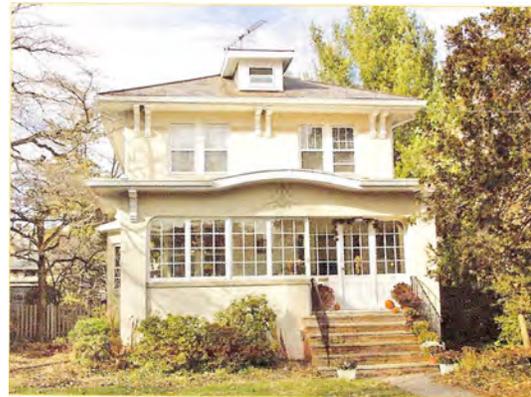
Bungalow/Craftsman Style

This style is characterized by the use of gently pitched roof with gable fronts, mostly with a separate lower gable roof over a front porch supported by brick piers. Shingles or bricks are used for the exterior finish in their natural color. Only the trim would be painted. Overall the elevations would have minimal ornamentation. Bungalows were modest structures designed for the modern middle class family. They are rare in Morristown. Some were available as kits from Sears Roebuck. However, the detailing of the Craftsman Style can sometimes be found on other building types such as the American Four-Square house, at right.

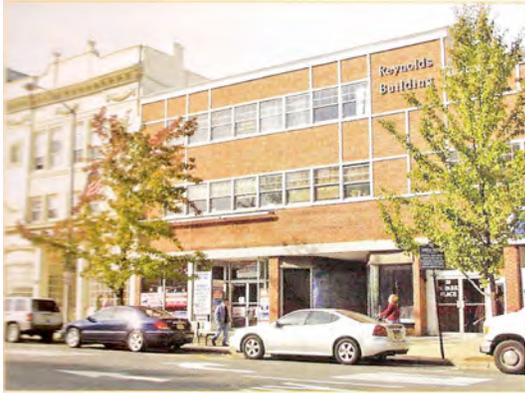
A streamlined look is created in the Art Moderne style by soft or rounded corners, flat roofs, smooth wall finishes without surface ornamentation, and horizontal bands of windows. Curved window glass that wraps around corners enhances the streamlined effect. Doors are of metal or wood and can be decorated with circular windows, large panels of glass, or patterns with circular and angular outlines. Adding to the machine age look of the style, door and window trim, railings, and balusters are often made of aluminum or stainless steel. Other modern decorative materials such as mirrored panels, concrete panels and, occasionally, metal panels with low relief designs around doorways and windows may be used.

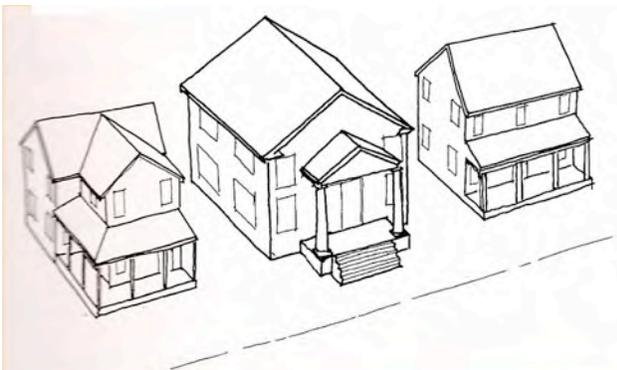
Scale

The size and shape of most building elements are generally standard: an existing doorway is known to be about 3 feet wide by about 7 feet tall; a typical brick is about 2 1/2" tall by 8" long. A new building with a 10 foot tall door or 8" by 16" blocks would be out of scale with the other buildings. This is especially evident in downtown areas, where numerous buildings adjacent to each other form a continuous street front wall. It is also important to maintain other comparable elements, such as floor-to-floor heights and the placement of cornice lines and belt courses separating the floors.

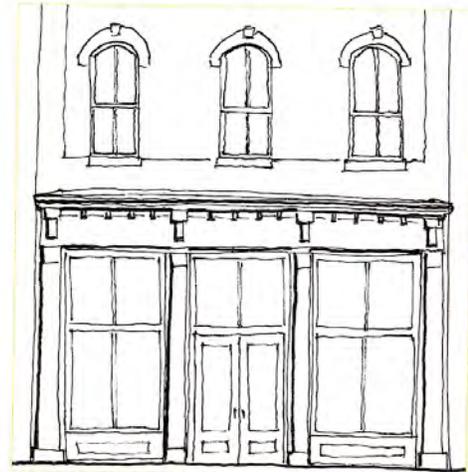
The availability of cast iron elements had a major impact on storefront design. The use of slender cast-iron columns allowed larger display windows, while cast-iron beams replaced the earlier stone and wood spans. Cast iron also offered tremendous decorative opportunities, since the molten metal could be poured into forms that were detailed for architectural expression as well as structural functionality. In larger cities, it was not uncommon for the entire facade of mid-to-late 19th century commercial buildings to be executed in cast iron. Because cast iron had to be painted, its decorative nature promoted the use of intricate paint schemes in bold Victorian colors.

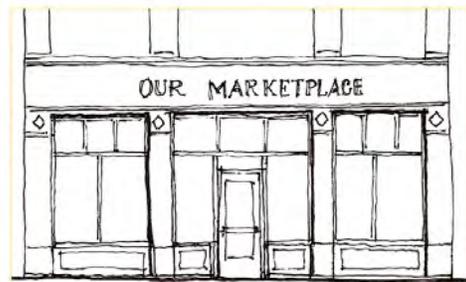
Signage is a very important visual aspect of a downtown area. Signage should be clear and simple. Extraneous signage should be eliminated as it detracts from primary advertising. Signage should be placed to complement the storefront's design. For example, signage can be architecturally centered above the storefront bays in the "signband" area of the storefront's cornice entablature, or placed on the valence of an awning. A line of signage painted along the base of the shop window will effectively identify the products sold therein (and can then be reinforced by the actual products displayed above in the window). Wood or metal signs are appropriate in a sign band; plastic signs and internally lighted signs are not historically or aesthetically appropriate. Signage for different businesses in the same building or sharing a single entablature should follow a similar design for uniformity and continuity. Signs should not be suspended from the architectural elements of the building such as balconies, cornices, trim or ornamentation; neither should they be directly applied to nor painted on such features or on the building facade. Historic shingle signs should be retained and repaired to their original appearance. It is very important that the colors of the signage, although contrasting with the background for clear visibility, should be compatible with the rest of the building.

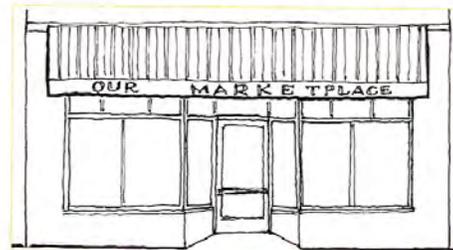
Grates

Solid roll-down security grates are a significant visual intrusion makes a neighborhood seem undesirable. Furthermore, solid grates prevent a passerby (including the police) from seeing intruders who have entered the store from the top or rear. In most cases, alarm systems provide sufficient protection from isolated incidents of broken windows. If a grate is absolutely necessary, open mesh grates instead of solid are visually preferable and should be installed inside the storefront windows to reduce their visual intrusion.

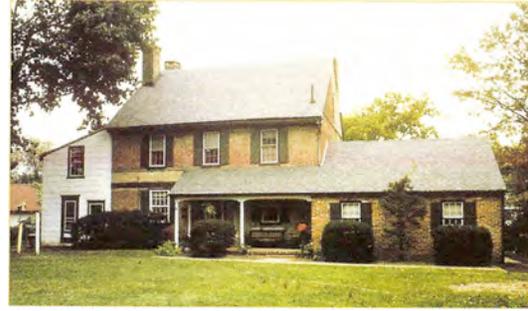
Site

Typical elements of site design found in residential neighborhoods include fencing (wrought, cast iron or wood); benches; decorative paving; and garden elements such as bird feeders, pavilions, historic horse mounts, fish ponds, water fountains, and sometimes artistic sculptures. While most urban commercial buildings typically stand shoulder to shoulder or with only narrow alleys between, some of these historic site elements may be encountered there as well. These elements should be repaired and maintained, since they connect the building to its surroundings. New site elements should be compatible in materials and style.

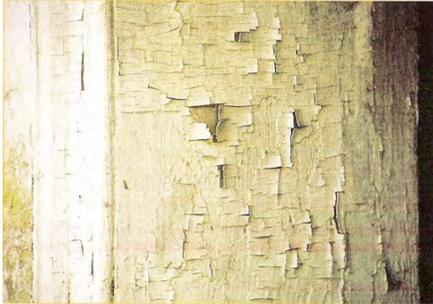
- o Check for bare spots, blistering, peeling and mildew. Check where moisture is entering wood and stop leaks. Wash mildew with fungicide. Split blisters, scrape peeling areas, remove rust and sand rough spots. Coat bare wood with preservative. Prime and paint wood with two coats of exterior house paint, using materials compatible with the preservative. Typically, paint has to be replaced every 5 to 8 years.

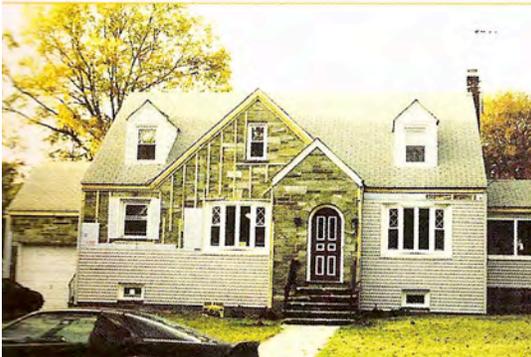
- o Check for moist areas, cracks, crumbling material, loose pieces, missing mortar and efflorescence (white discoloration). Determine where moisture is entering masonry and repair any leaks in roofing, cornice, flashing, downspouts, and joints between masonry and other materials. Replace flashing or re-caulk leaking joints as required. If significant cracks, movement, surface spalling, or material deterioration are found, review condition of masonry with registered architect or professional engineer experienced in methods of evaluating brick and masonry. Make repairs as necessary in accordance with professional recommendations. Repair or provide additional support to door or window heads which are unstable. Vinyl siding or stucco should never be applied to hide damaged masonry; proper repairs should be undertaken.

- o Check for loose units of masonry and missing or deteriorated mortar. Repoint joints that have loose or crumbling mortar, using mortar that matches original in color, texture, constituent composition, and workmanship. Mortar should not have high Portland cement content and should be no harder than surrounding brick or masonry or original mortar. Conduct the following procedure: remove deteriorated or loose mortar with hand tools to a minimum depth of 2.5 times joint width; clean joints; apply fresh mortar to wetted joints in layers not thicker than one quarter inch. Joints should be slightly recessed to maintain original width and

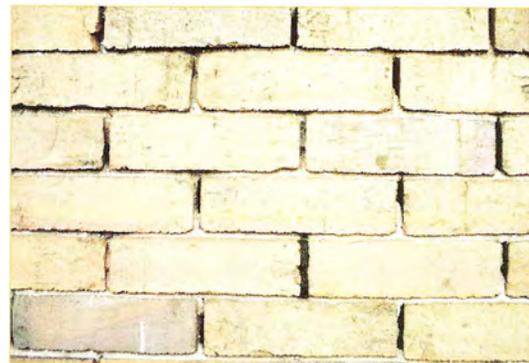
- o If the masonry is heavily soiled, clean only with materials and techniques that will not damage the masonry. Scrubbing with natural bristle brush wetted with natural detergent in water is usually sufficient to remove dirt and grime. Sandblasting, wire brushes, grinders, sanding discs, or other abrasive methods should not be used, nor should any harsh chemical that weakens the masonry be applied. Any chemical cleaner, if required, should be chemically neutralized and thoroughly rinsed off in order to remove residues that could damage masonry or finishes. Pressure water washing, if

necessary, should be low pressure (not exceeding 600 psi pressure at the nozzle or 4 g.p.m. volume). Never clean masonry when there is any possibility of frost, as the absorbed moisture will freeze within the wall causing severe damage.

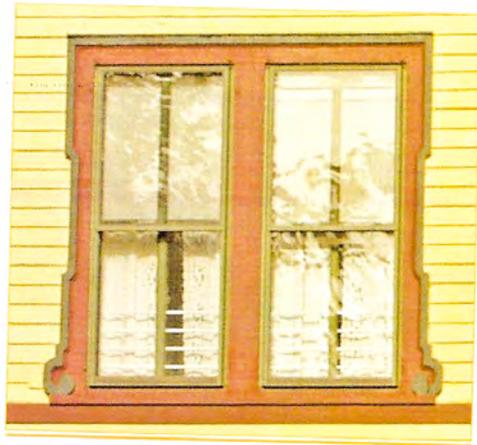
Architrave

The ornamental molding/trim around jambs and head of a wall opening.

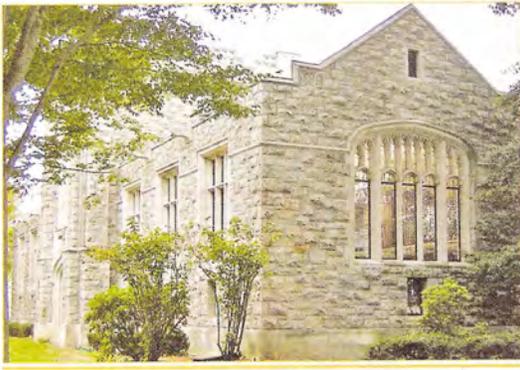
Ashlar

Quarried stone building blocks that have been squared and finished with a smooth surface; beginning **in** the 19th century, the term indicates facing backed by rubble or brick walls.

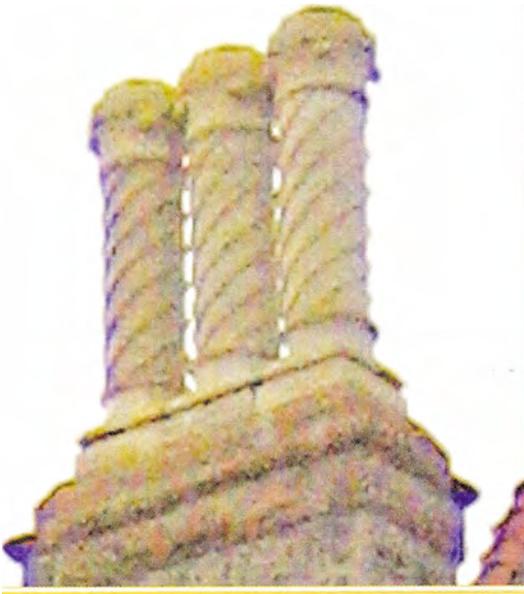
Chimney Pot

An extension of the top of a chimney above the masonry; usually of decorative terra-cotta; in a cylindrical, octagonal or spiral shape; commonly found in Tudor Revival style buildings.

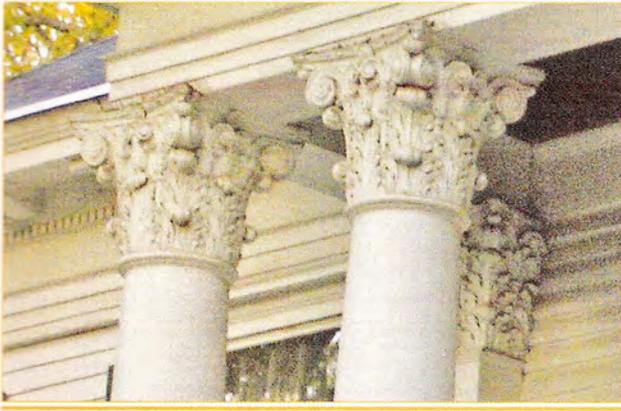
Corinthian

The most ornate of the five classical orders of architecture, used to describe a fluted column with a bell shaped capital comprised of two rows of acanthus leaves, topped by volutes and decorative abacus.

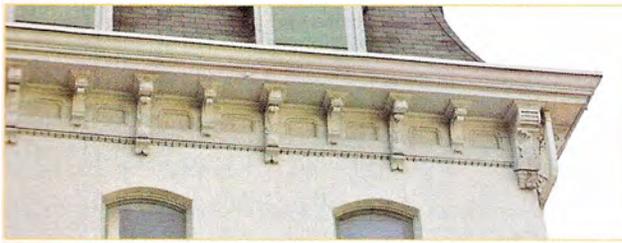
Cornice

A continuous projecting horizontal element at the top of a wall.

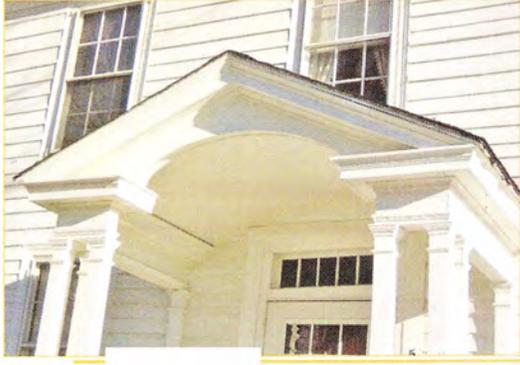
Door Hood

A decorative and functional projecting pediment above the door.

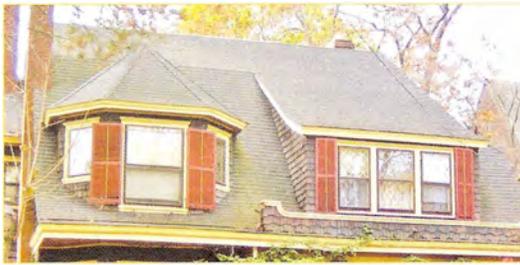
Dormer

A projecting vertical structure on the slope of a roof which provides light and headroom to the interior space.

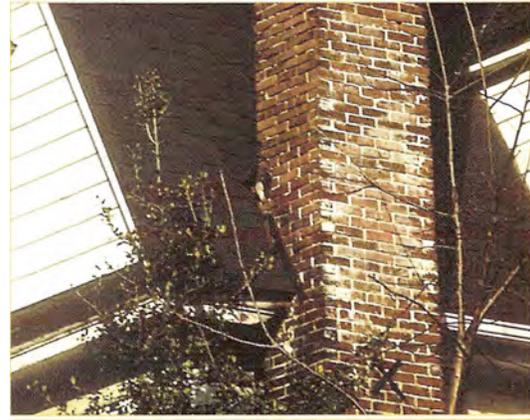
Efflorescence

A deposit of soluble salts on the face of masonry, brought from within by water entering the wall.

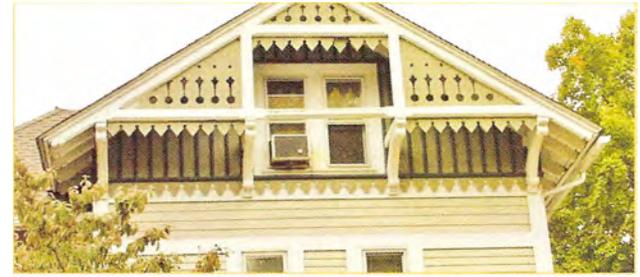
**Fretwork**

A screen or latticework composed of intricate interlaced openwork.

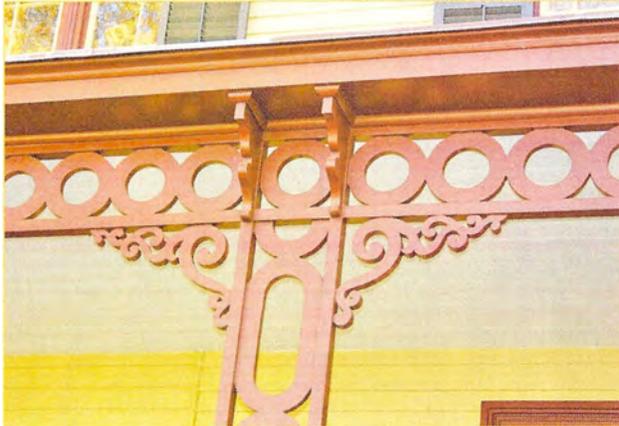
Gingerbread

A colloquial, but widely accepted term for decorative, sawn ornamentation on Victorian-period houses.

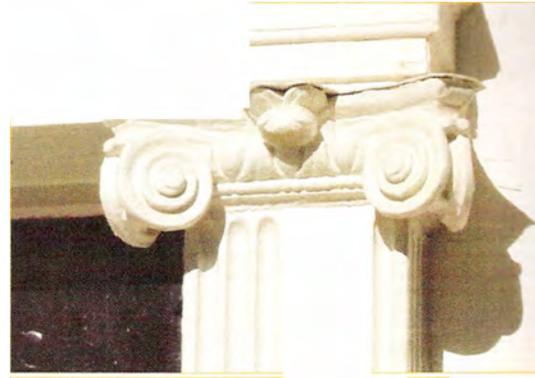
Ionic

One of the five classical orders of architecture, used to describe decorative scroll capitals.

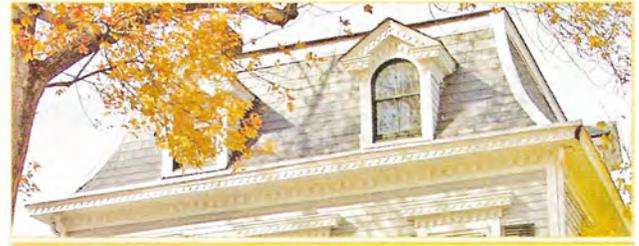
Mansard Roof

A roof with two slopes on each side, the lower of which is very steep and usually covered with slate. This roof form characterizes houses of the Second Empire Style.

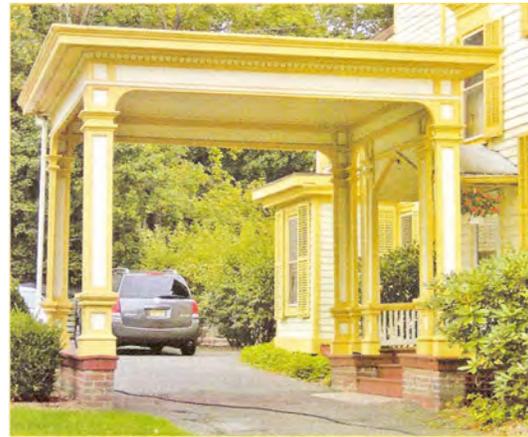
**Porte Cochere**

A covered area over a driveway at a building entrance. Also known as carriage porch.

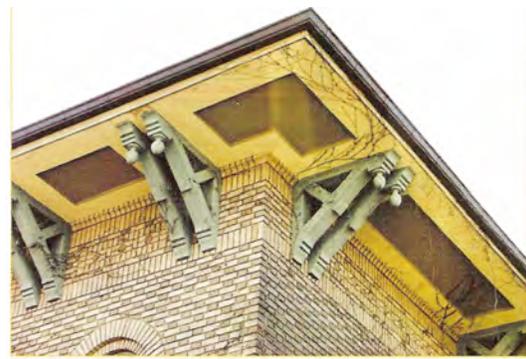
Soffit

The exposed underside of a cornice, eave, or other spanning element.

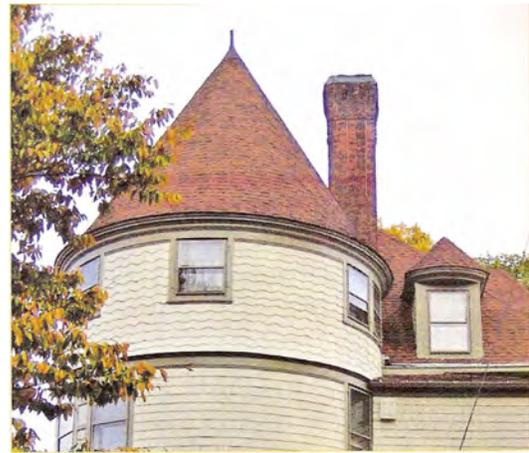
**Turret**

A small tower with a steep pointed roof, usually found at one corner of Queen Anne Style buildings.

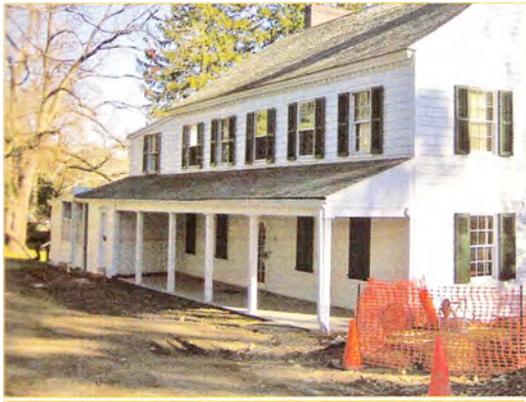
Veranda

Another term for porch; a veranda typically extends along an entire side wall.

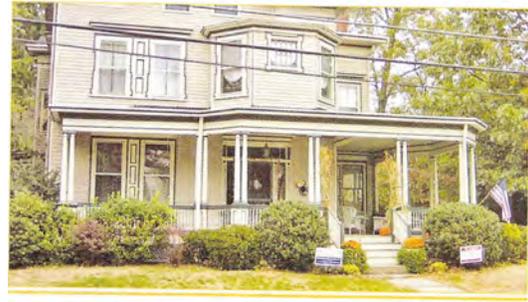
Wrap-Around Porch

A front porch which turns one or both of the building's corners to continue along the side.

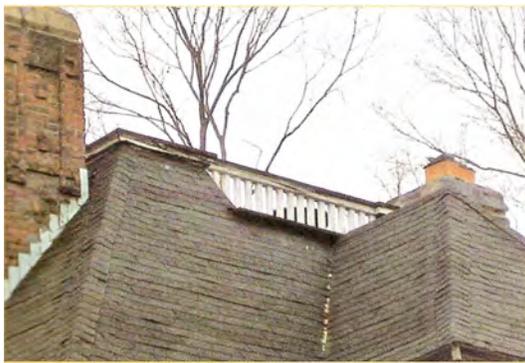
Widow's Walk

A decorative balustrade at the top of a hipped roof
