ENVIRONMENTAL RESOURCE INVENTORY

UPDATE ~ 2011

Town of Morristown

Adopted October 27, 2011

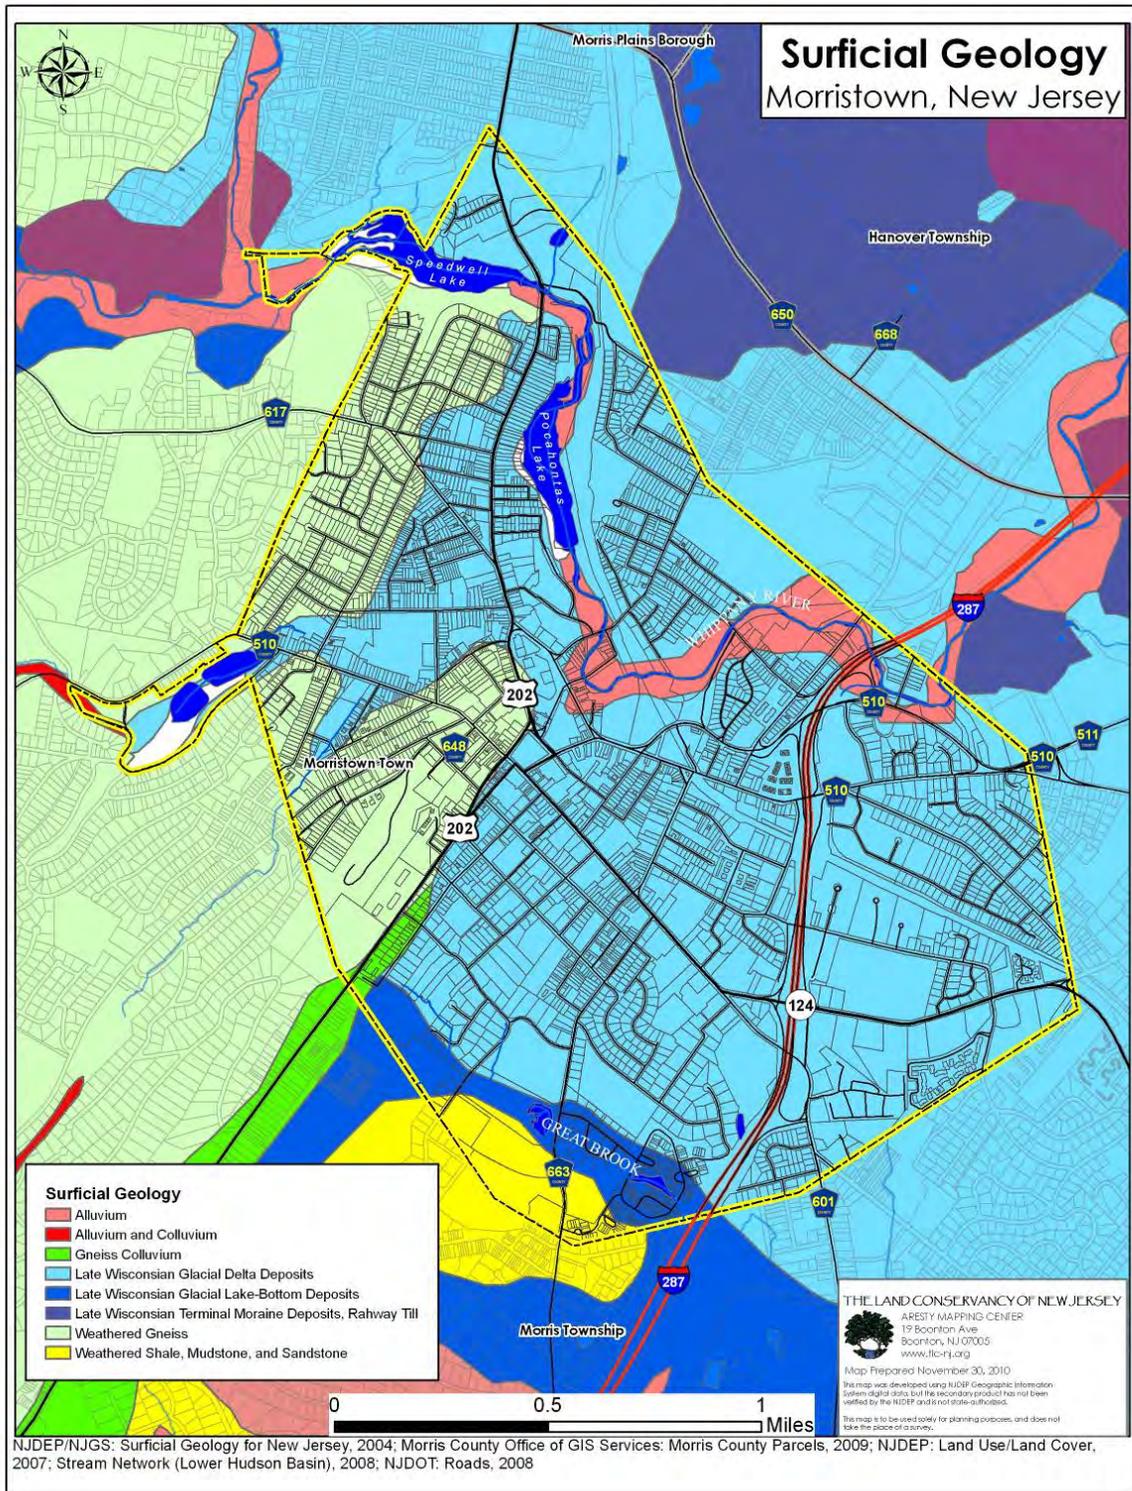
Figure 6: The Surficial Geology of the Town of Morristown, NJ

Surficial geology is the unconsolidated materials overlaying bedrock formations. They are the parent material for agronomic (capable of supporting agriculture) soils. They also affect the movement of groundwater and are capable of containing aquifers (*NJDEP, DGS10-2 Surficial Geology of New Jersey*). **Figure 6** depicts the surficial geology of Morristown. The majority of the town (74.6%) is covered in Late Wisconsinan glacial sediment, including delta deposits, lake-bottom, and terminal moraine deposits. The second most common material (17.2%) is weathered gneiss rock, which is found in the Highlands physiographic region of the Town. **Table 5** presents a summary of surficial geology in Morristown.

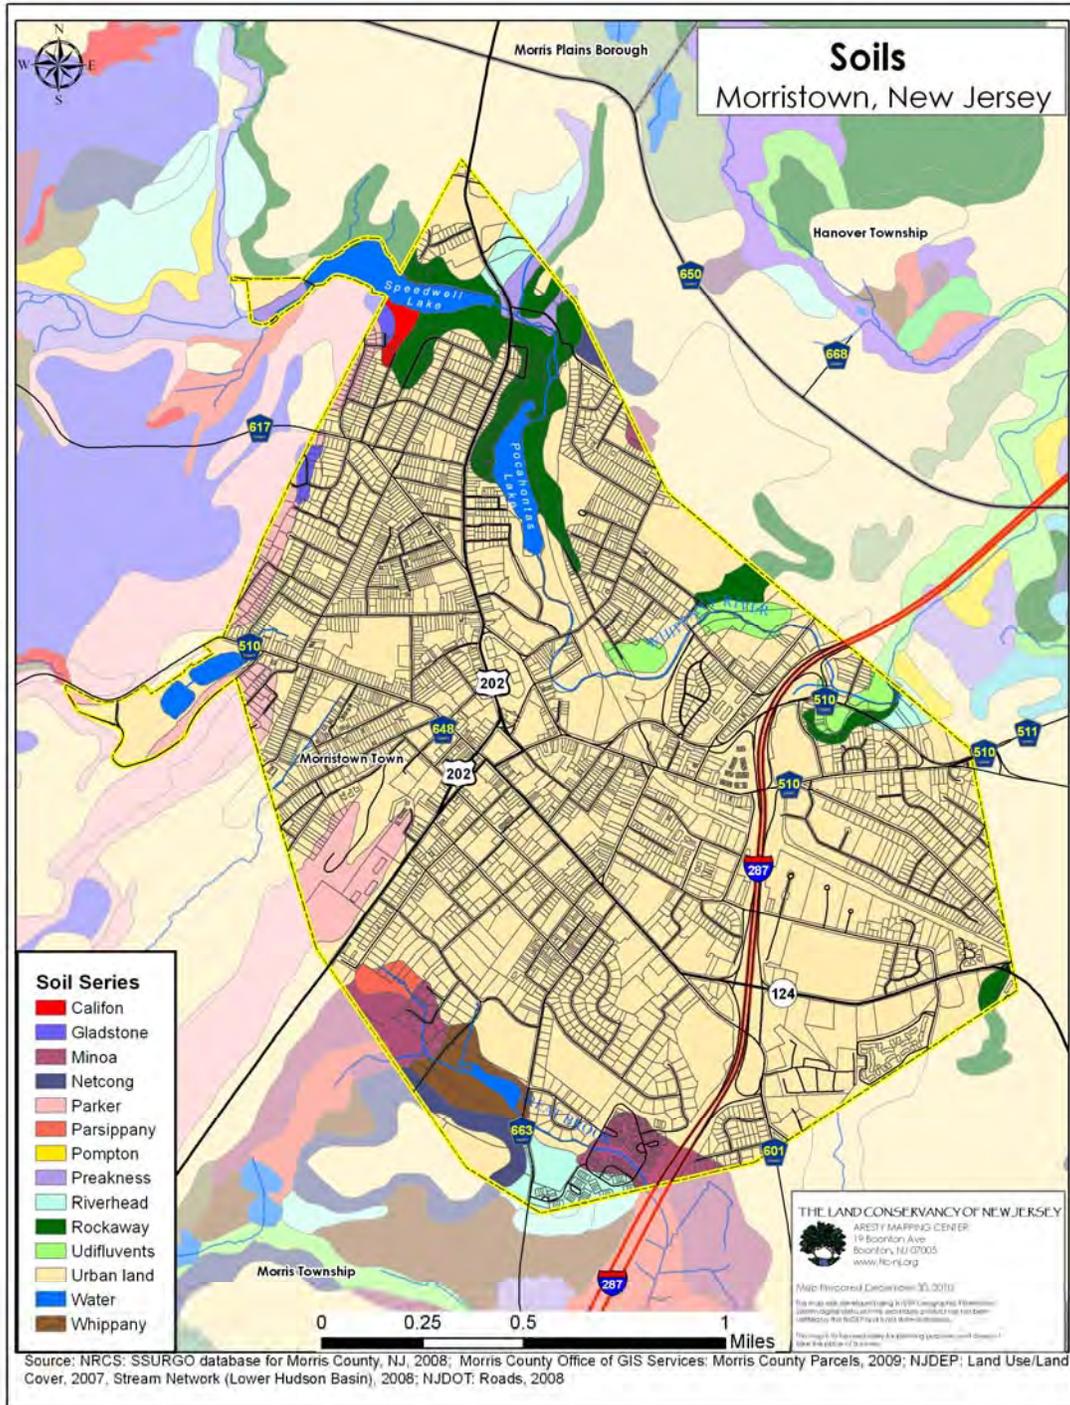
Figure 7: Soil Series within the Town of Morristown, NJ

The majority of soil in Morristown has been disturbed to such an extent by human activity that is classified as urban land. Below is a description of the soils series of Morristown.

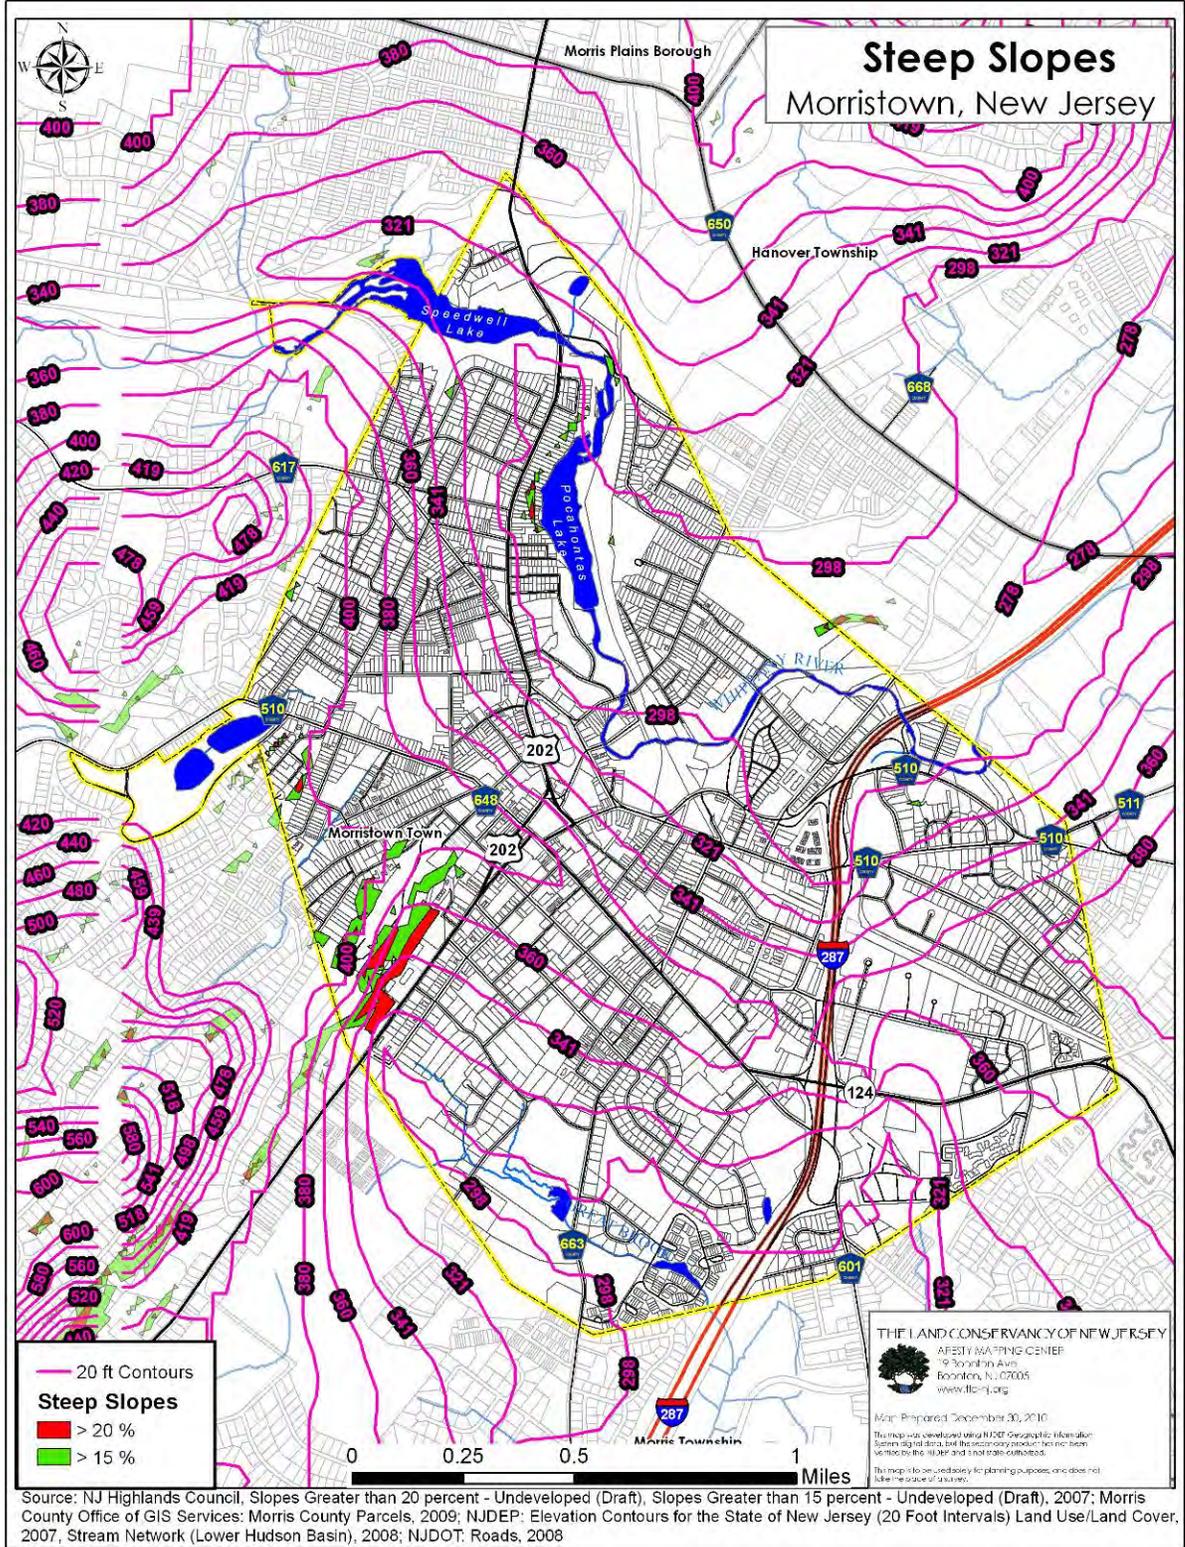
Figure 9: Steep Slopes in the Town of Morristown, NJ

With much of Morristown characterized by the relatively flat land of the Piedmont physiographic, there are few areas of steep slopes in the municipality. These areas mostly occur in the western portion of town where the Highlands region begins. **Figure 9** shows the steep slopes of the area using data from the New Jersey Highlands Council, which delineates between those slopes greater than 15% and those greater than 20%. It should be noted that individual parcels may contain significant slopes that are not represented on the map due to the limitations of the mapping scale.

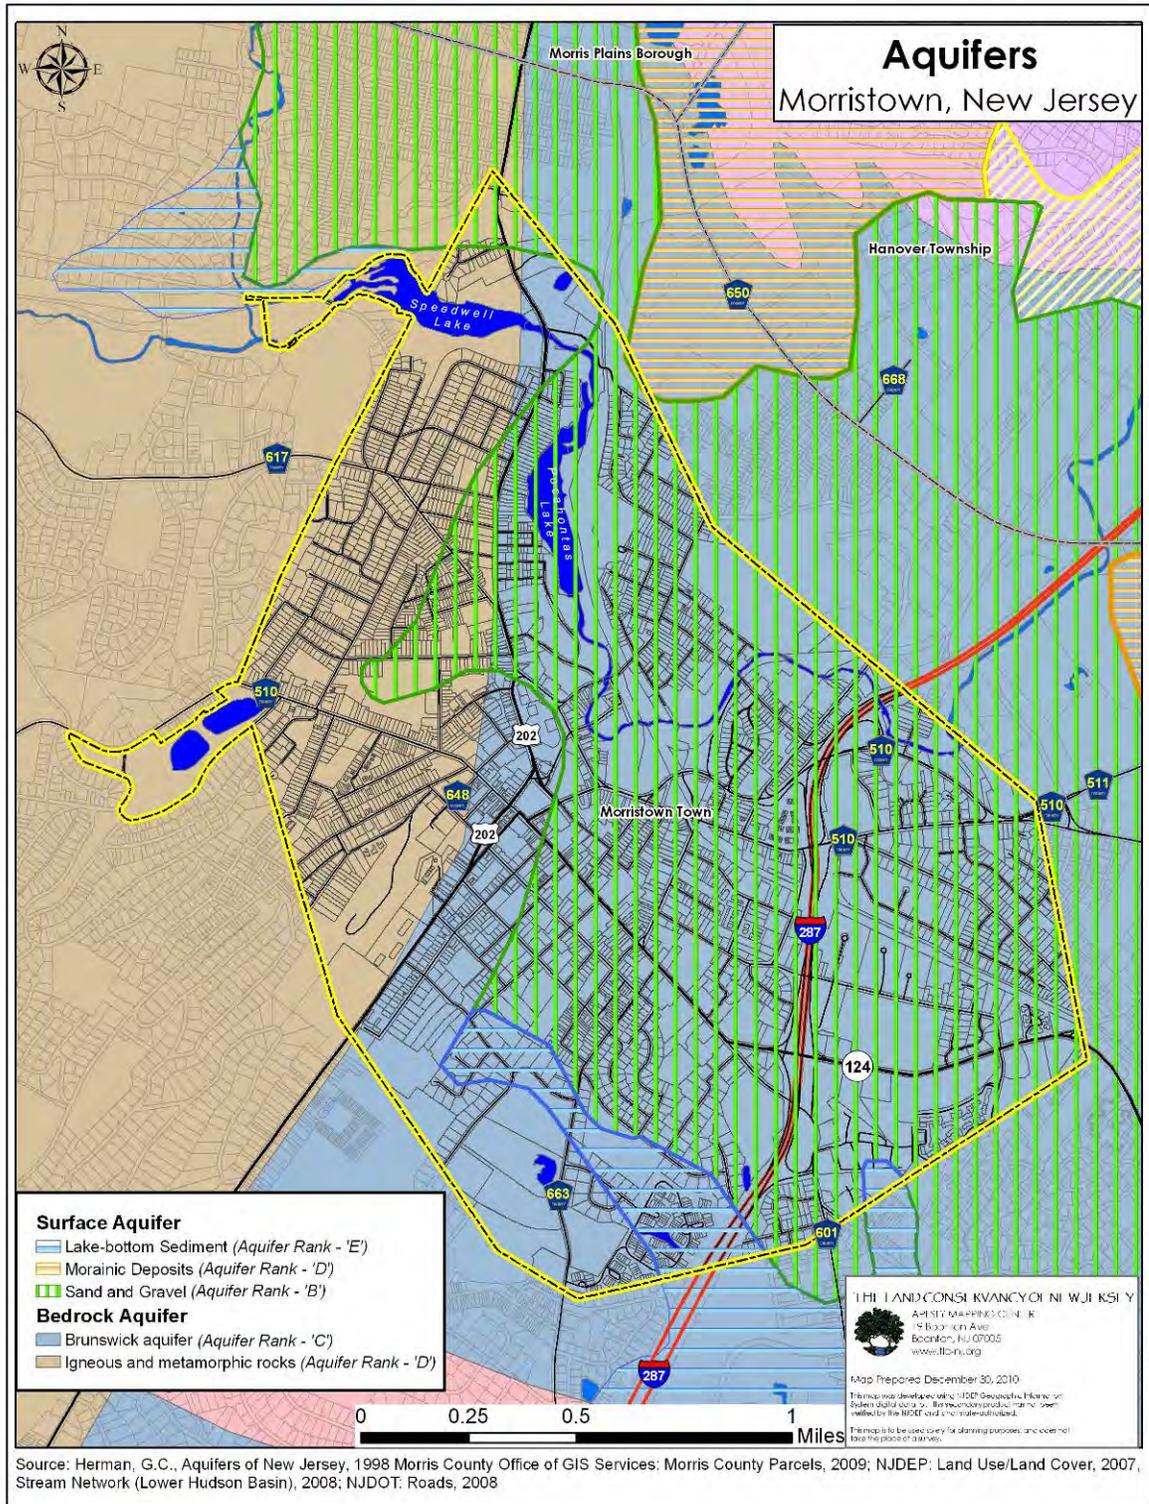
Figure 11: Bedrock and Surficial Aquifers in the Town of Morristown, NJ

Surficial Aquifers – Surficial aquifers in northern New Jersey consist of glacial sediment exceeding 50 feet in thickness. In Morristown, surficial aquifers cover about 64% of Morristown, mostly in the piedmont physiographic region. **Table 10** provides a summary of surficial aquifers in Morristown.

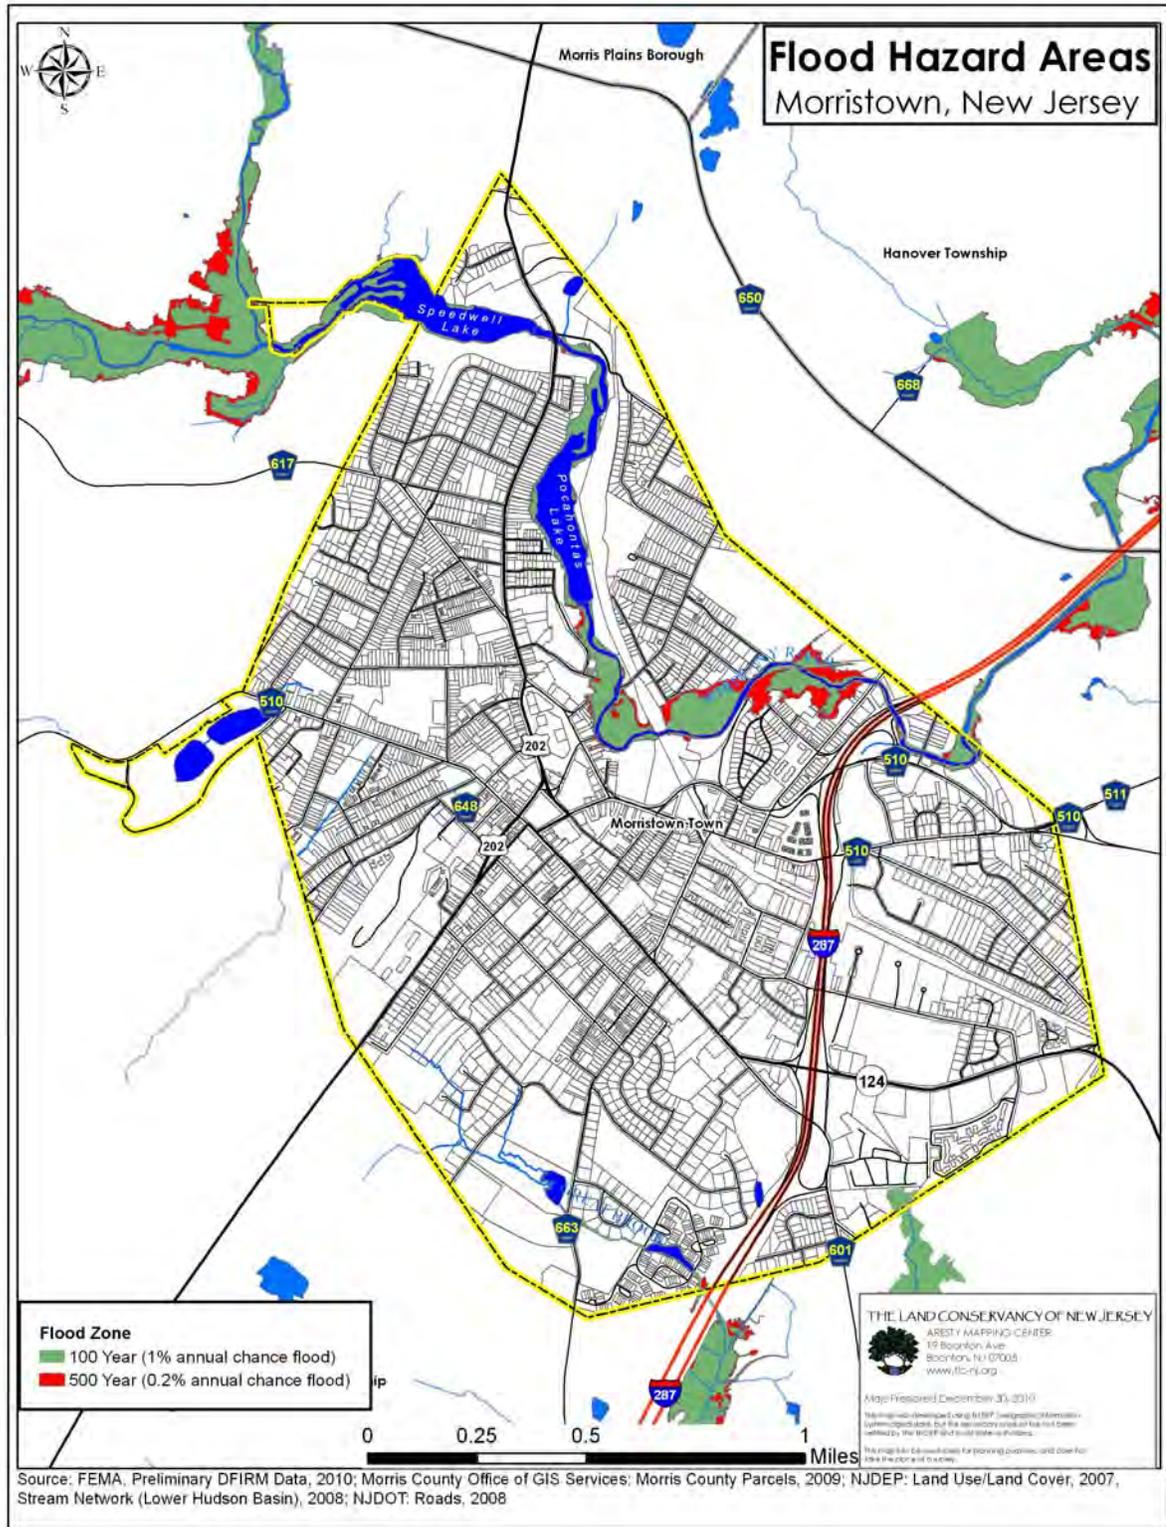
Figure 13: Flood Hazard Areas for the Town of Morristown, NJ

Northern Morristown, along the Whippany River, is susceptible to the greatest amount of flooding, with a small floodplain area also found along Great Brook to the south. In total, 6% of Morristown lies within the 100 or 500-year floodplain, **Table 11** presents a summary of flood hazards in Morristown.

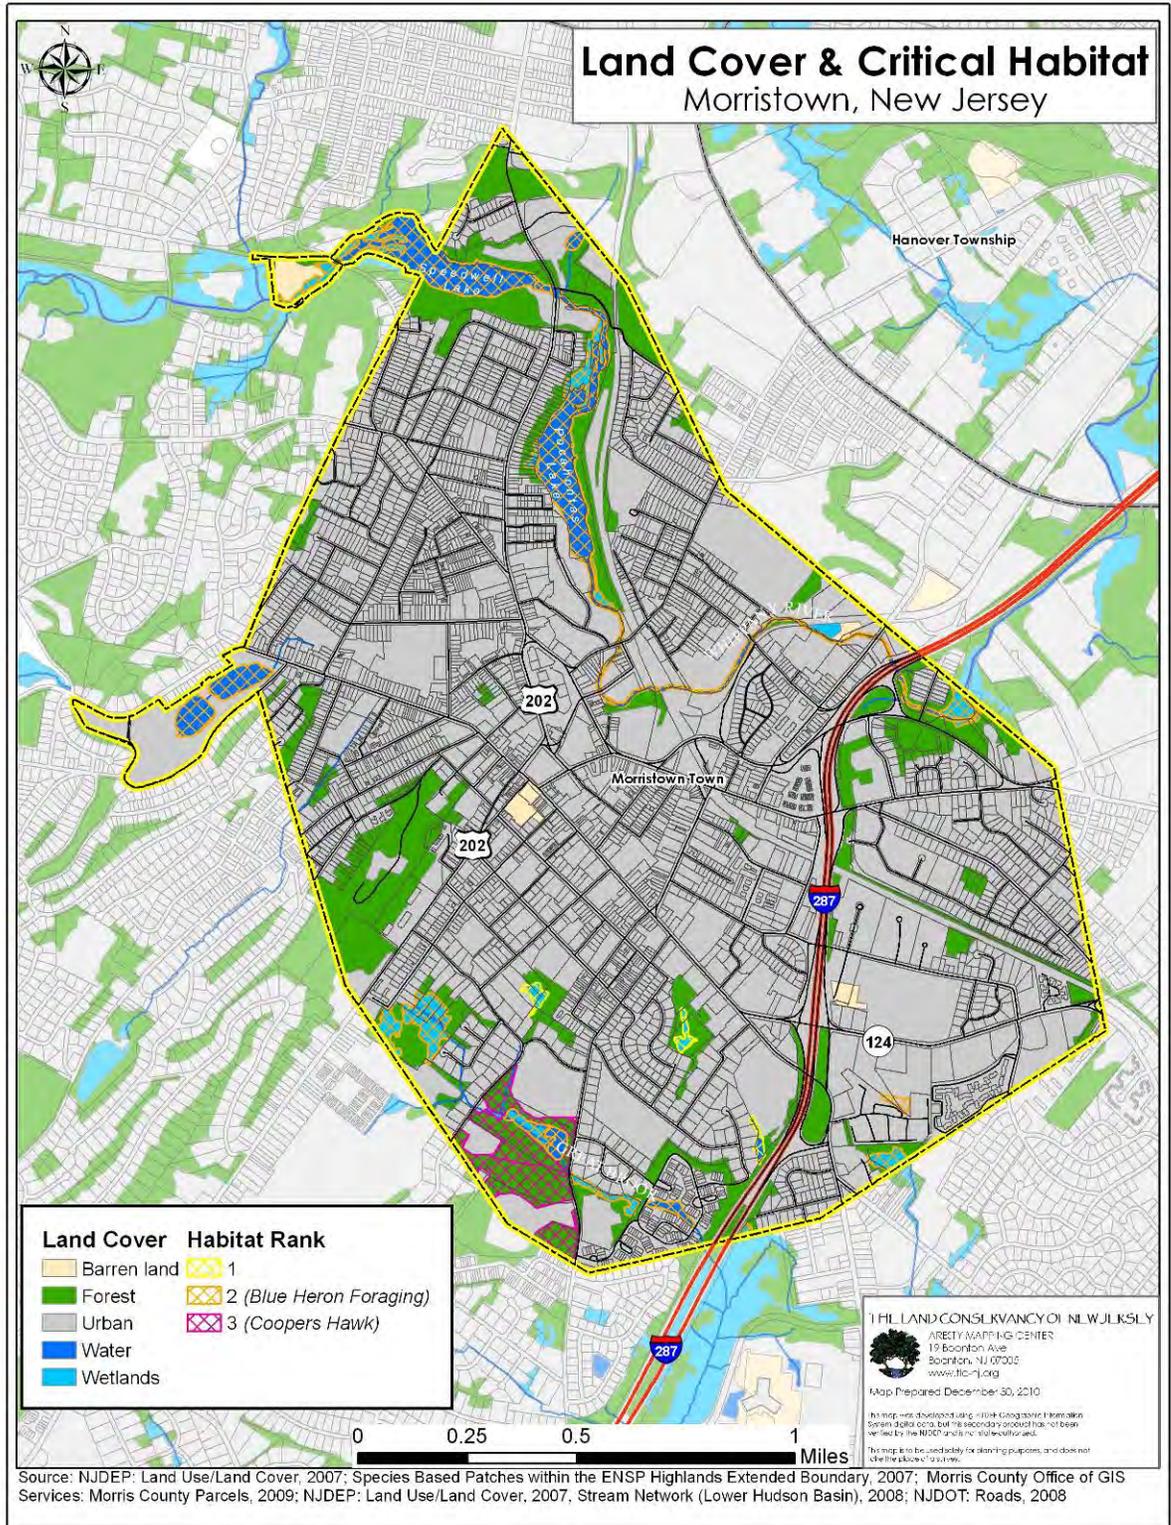
Figure 15: Land Cover & Critical Habitat Within the Town of Morristown, NJ

Figure 13 also depicts habitat patches in Morristown. Morristown contains habitat patches with ranks 1, 2, and 3, with rank 0 omitted from the map. The majority of the habitat patches (85 acres) in Morristown are ranked 2. According to the NJDEP data, these sites have had one or more occurrences of Great Blue Heron foraging activity. There are 29 acres of environmentally significant habitat in Morristown, all of which is located in and around Footes Pond Park. These patches have contained one or more occurrences of Coopers Hawk, a State threatened species. **Table 14** presents a summary of habitat patches within Morristown.
